DISPERSED RIPARIAN CAMPSITE MANAGEMENT IN THE
GREENWATER RIVER WATERSHED,
WASHINGTON

A Thesis
Presented to
The Graduate Faculty
Central Washington University

In Partial Fulfillment
of the Requirements for the Degree
Master of Science
Resource Management

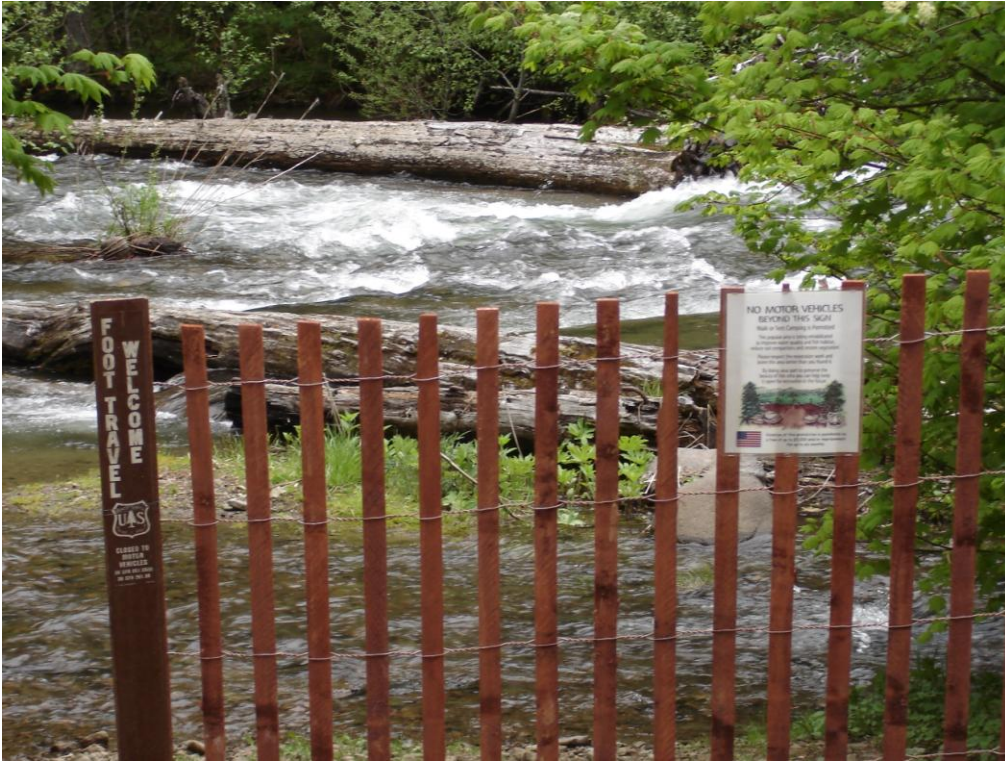
Figure 7. Carsonite® post, fence, and sign in site 7031-05, which was inundated by a seasonal side channel in spring 2006.

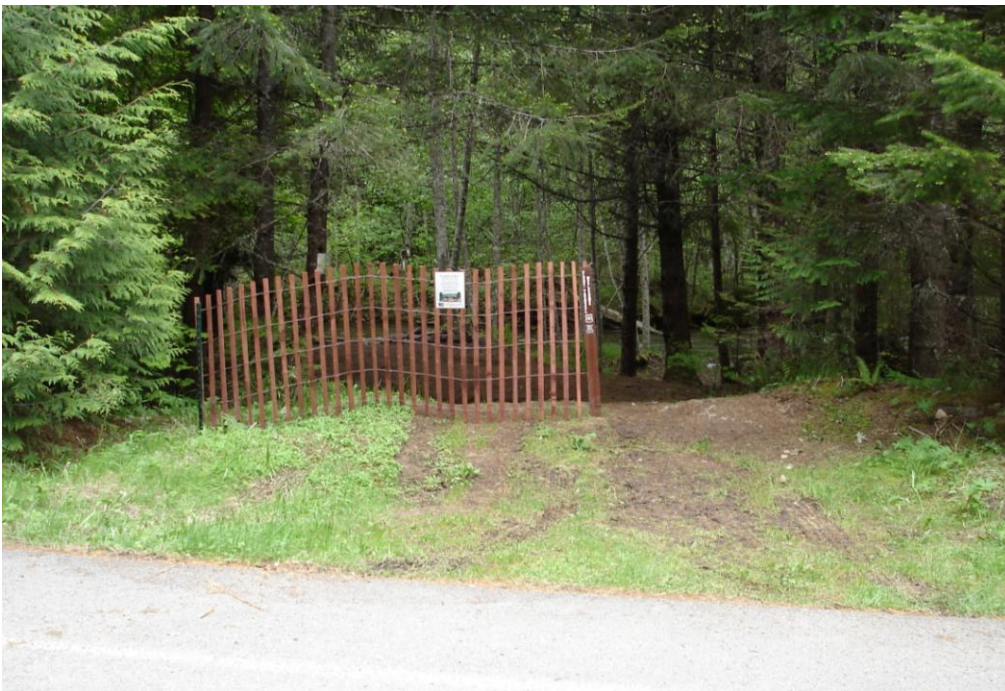
Figure 8. Fence and sign blocking vehicle access to site 7000-03.

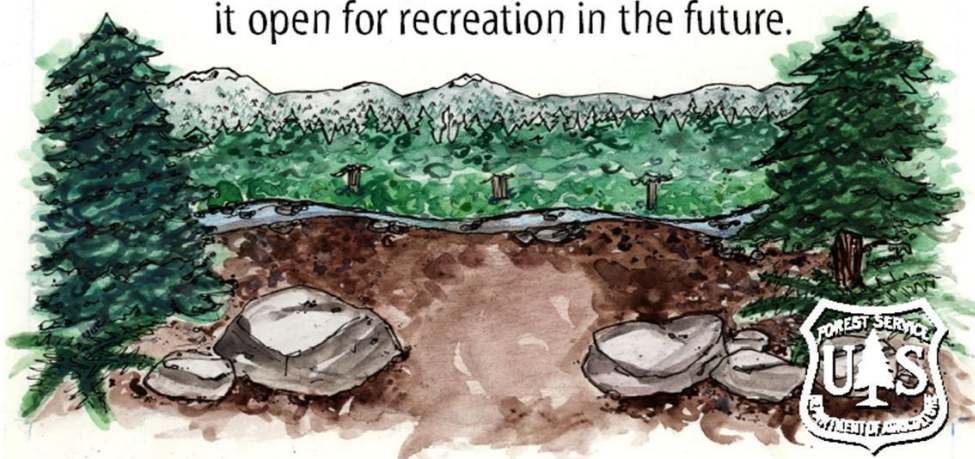
Figure 9. Sign posted at treated campsites.

I posted signs in sites selected for treatment stating that motor vehicles were not allowed, but walk-in camping was permitted (Figure 9). The signs included applicable federal codes (36 CFR 261.58(g) and/or 36 CFR 261.56) and potential penalties for violation. An image of the American Flag was included next to the text, which anecdotal evidence from other Forest Service land managers had shown to reduce vandalism of the signs. The signs were printed on a color laser printer and laminated to protect the paper from moisture. I also installed 6-foot Carsonite® boundary markers (similar to highway mile-

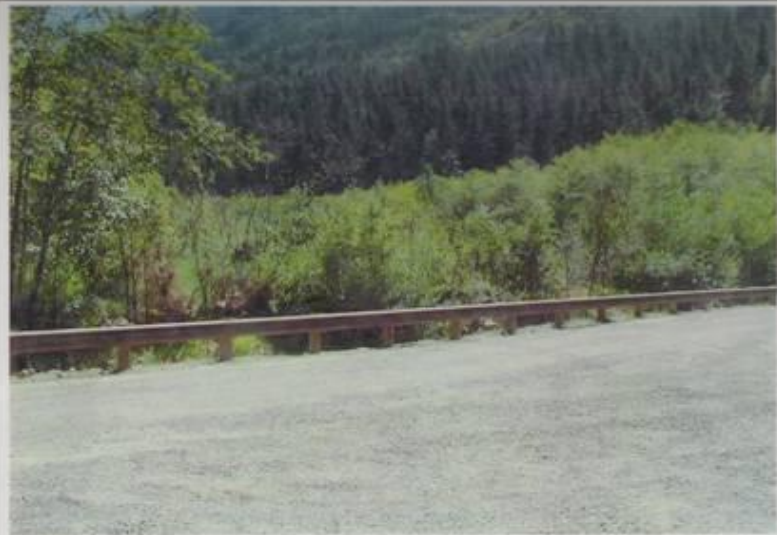
Option C: Guardrails to prevent vehicle access to stream, walk-in camping allowed.

Figure 11. Management options C and D presented to campers.

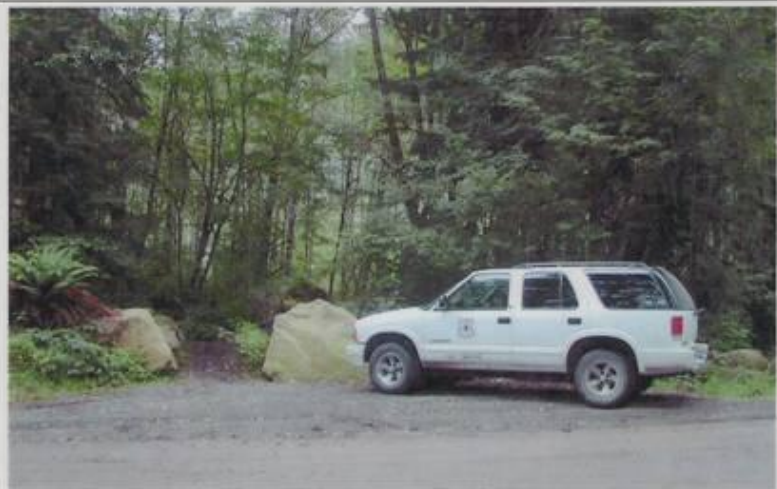
Option D: Boulders to prevent vehicle access to stream, walk-in camping allowed.

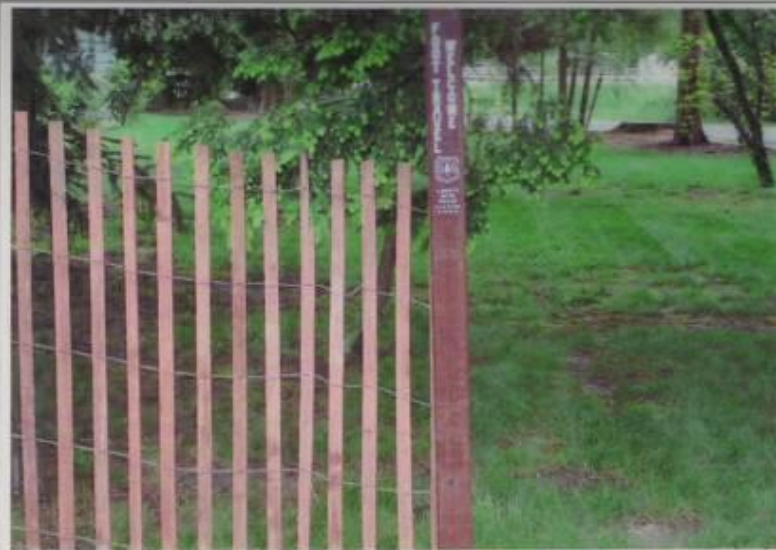
Option E: Lightweight wood fences and signs to prevent vehicle access to stream, walk-in camping allowed.

Figure 12. Management options E and F presented to campers.

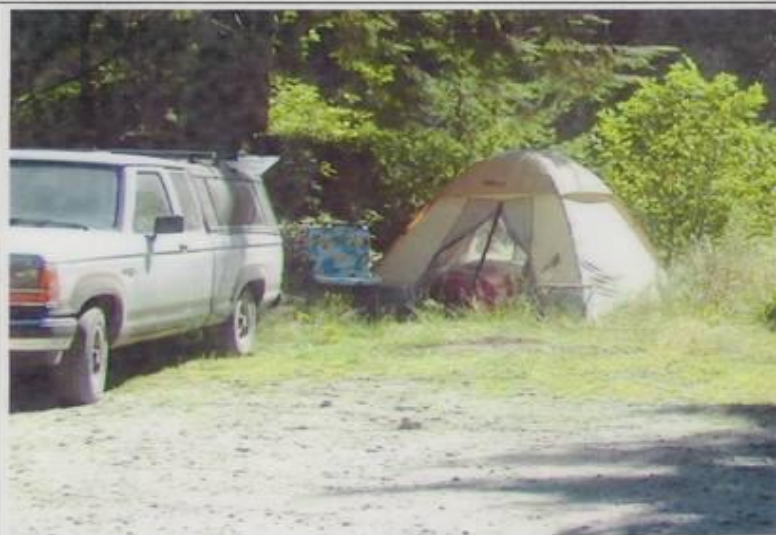
Option F: No action. Vehicles are allowed to drive and park on stream bank.

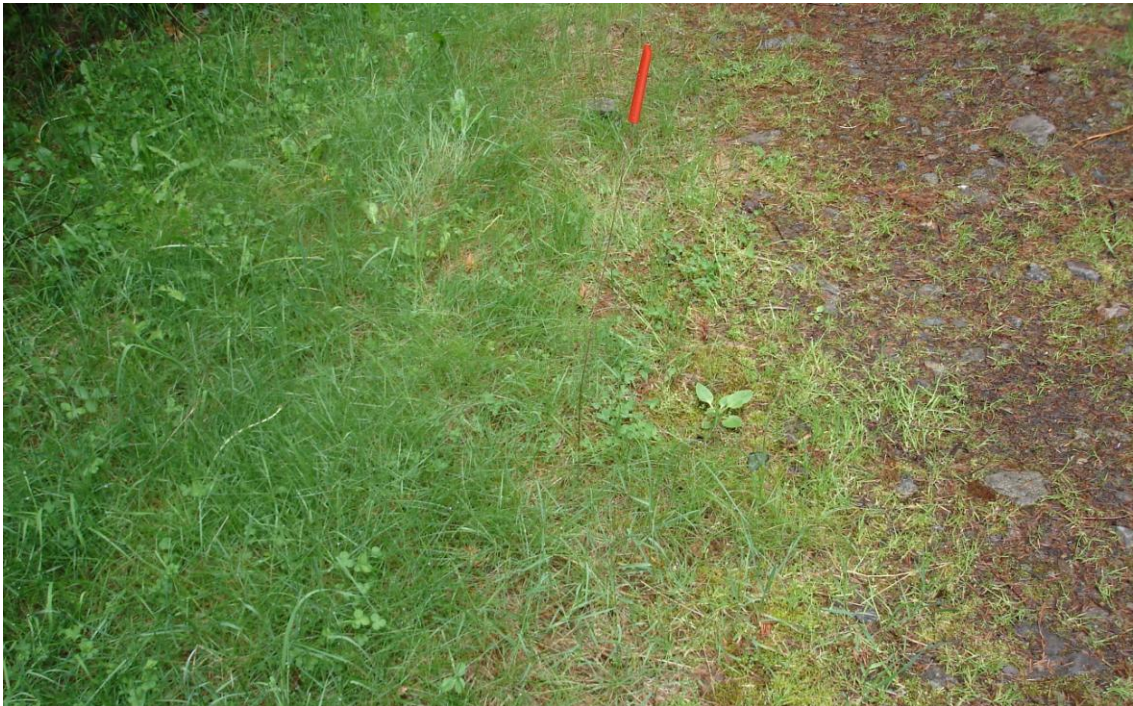
Figure 13. Example of campsite boundary with a survey flag inserted between obviously trampled vegetation and relatively un-trampled vegetation.

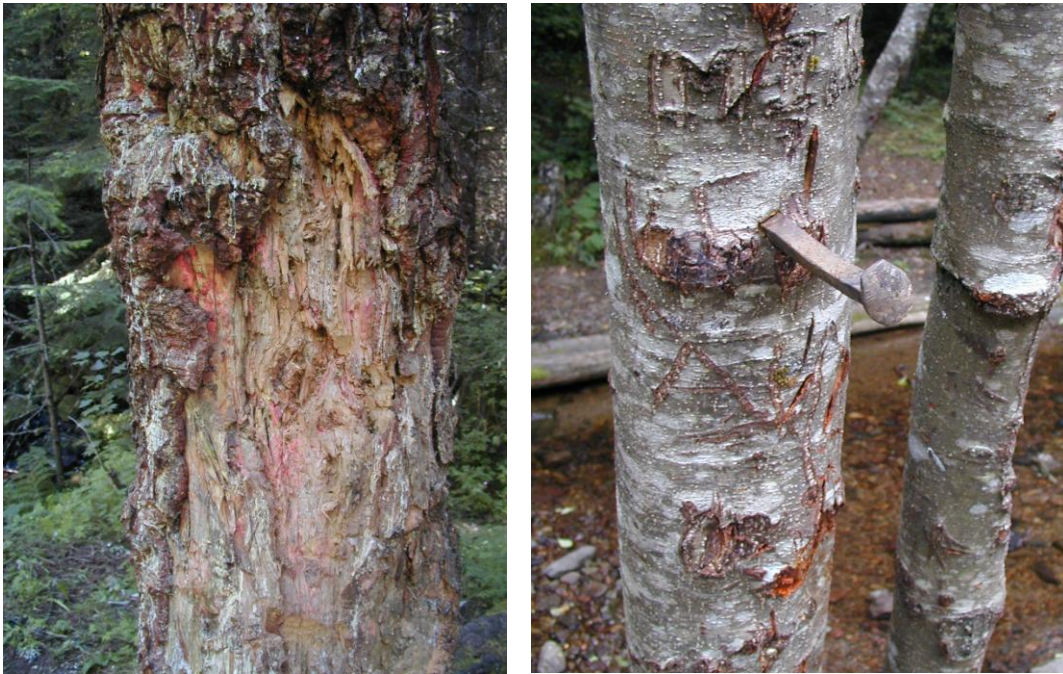
Figure 14. Damaged riparian trees in dispersed campsites.

Location and general condition of trees within the site area or within two meters of the boundary were recorded on site forms. Only relatively mature trees were counted (greater than 20 cm diameter at breast height). Tree location was recorded in the same manner as site boundaries: a measuring tape was stretched from the center stake to the center of the bole (estimated from the side of the tree), and length and azimuth were recorded in the field. Trees were not identified by species or size, other than meeting the minimum diameter for documentation. Trees, classified by the amount of damage observed, were

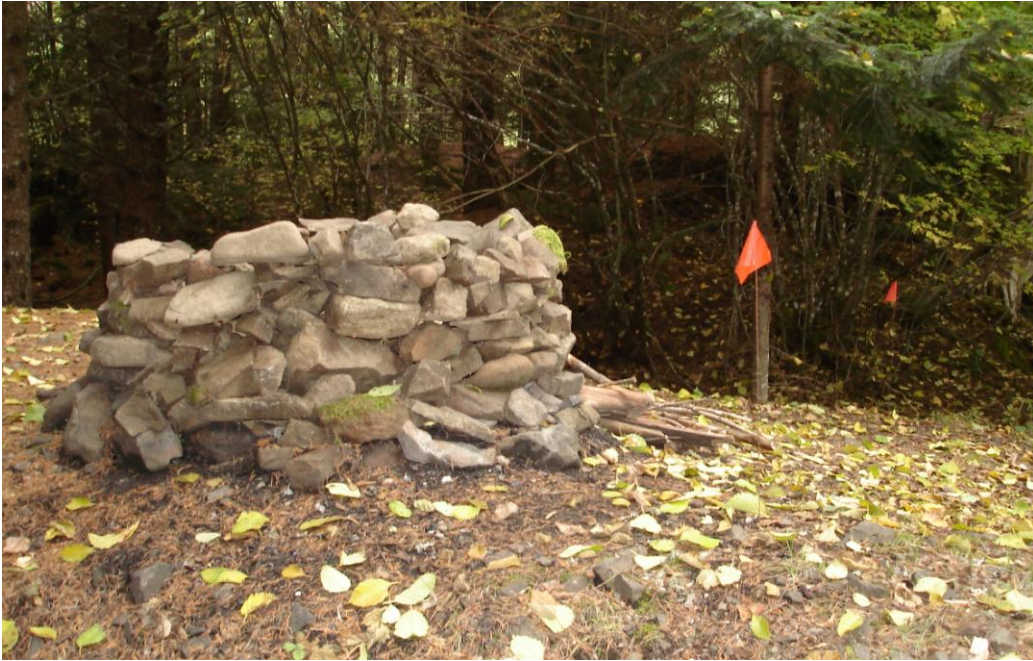
Figure 15. A carefully constructed fire ring in campsite 7000-03.

Location and size (diameter in meters) of fire rings was recorded. Fire rings were identified by a recognizably intact circle or oval of rocks with burned material contained within the ring. Blackened areas, piles of ash, and discarded briquettes, all of which could have indicated past use as a fire ring, were not included. Location was recorded in the same manner as the site boundary, measured from the center of the fire ring. Size of the fire ring was measured at the outside edges of the widest point of the rock ring.

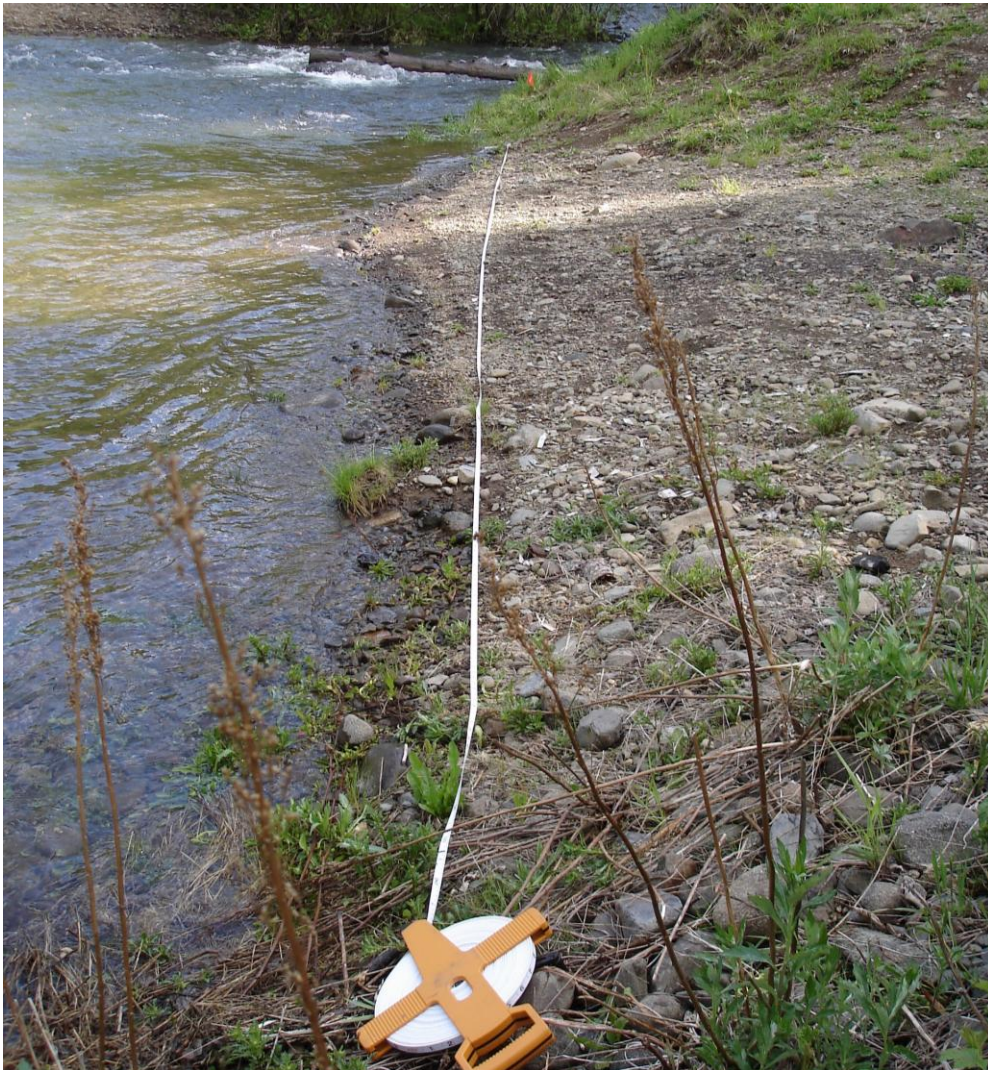
Figure 16. Non-vegetated streambank measurement in campsite 7031-03.

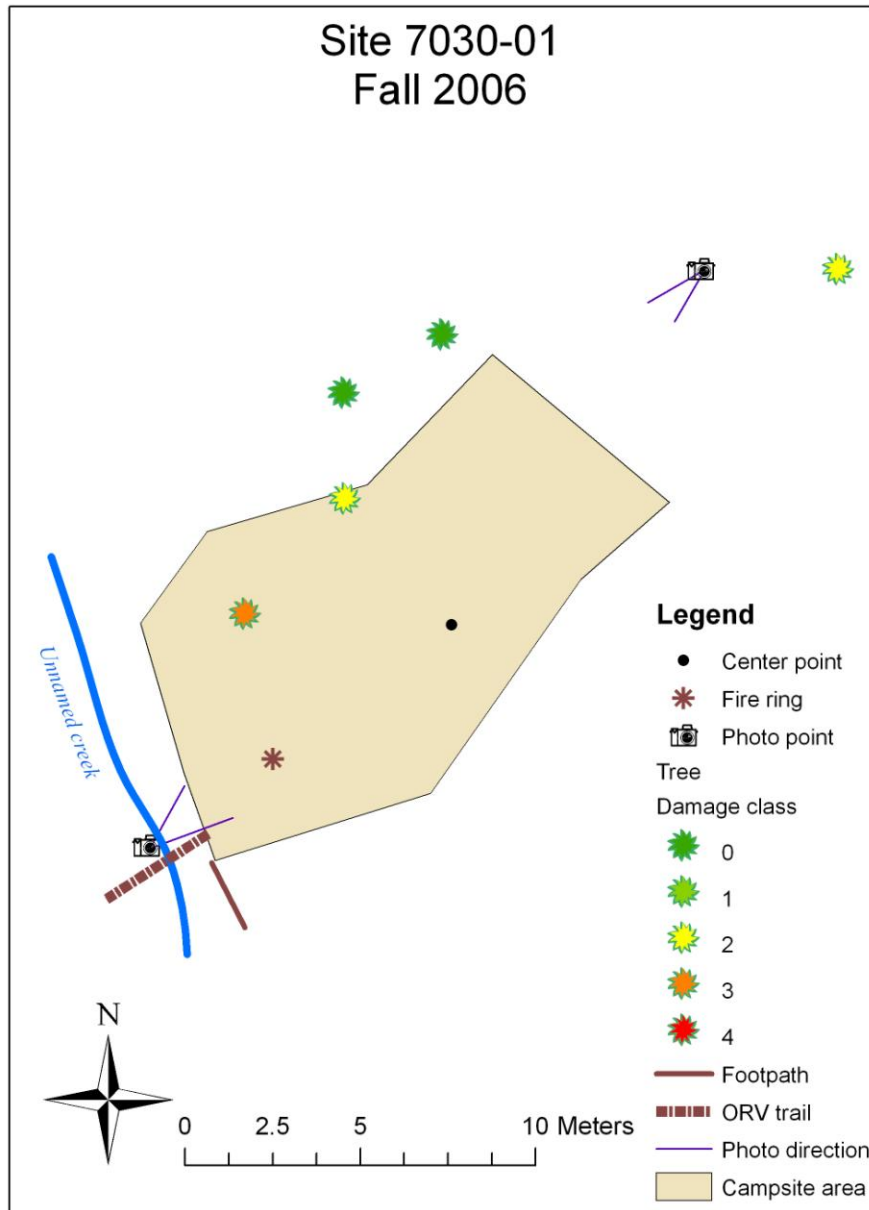
Figure 26. Map of campsite #7030-01, spring 2006.

Figure 27. Map of campsite #7030-01, fall 2006.

Campsite 7030-01 (Figures 26 and 27) is located on a small, unnamed tributary to the Greenwater River, and is accessed by a decommissioned road spur from FR 7030. The site appears to be located on one side of a removed culvert crossing. The site is moderately used, private, and probably because of its steep approach, not typically used by RV campers.

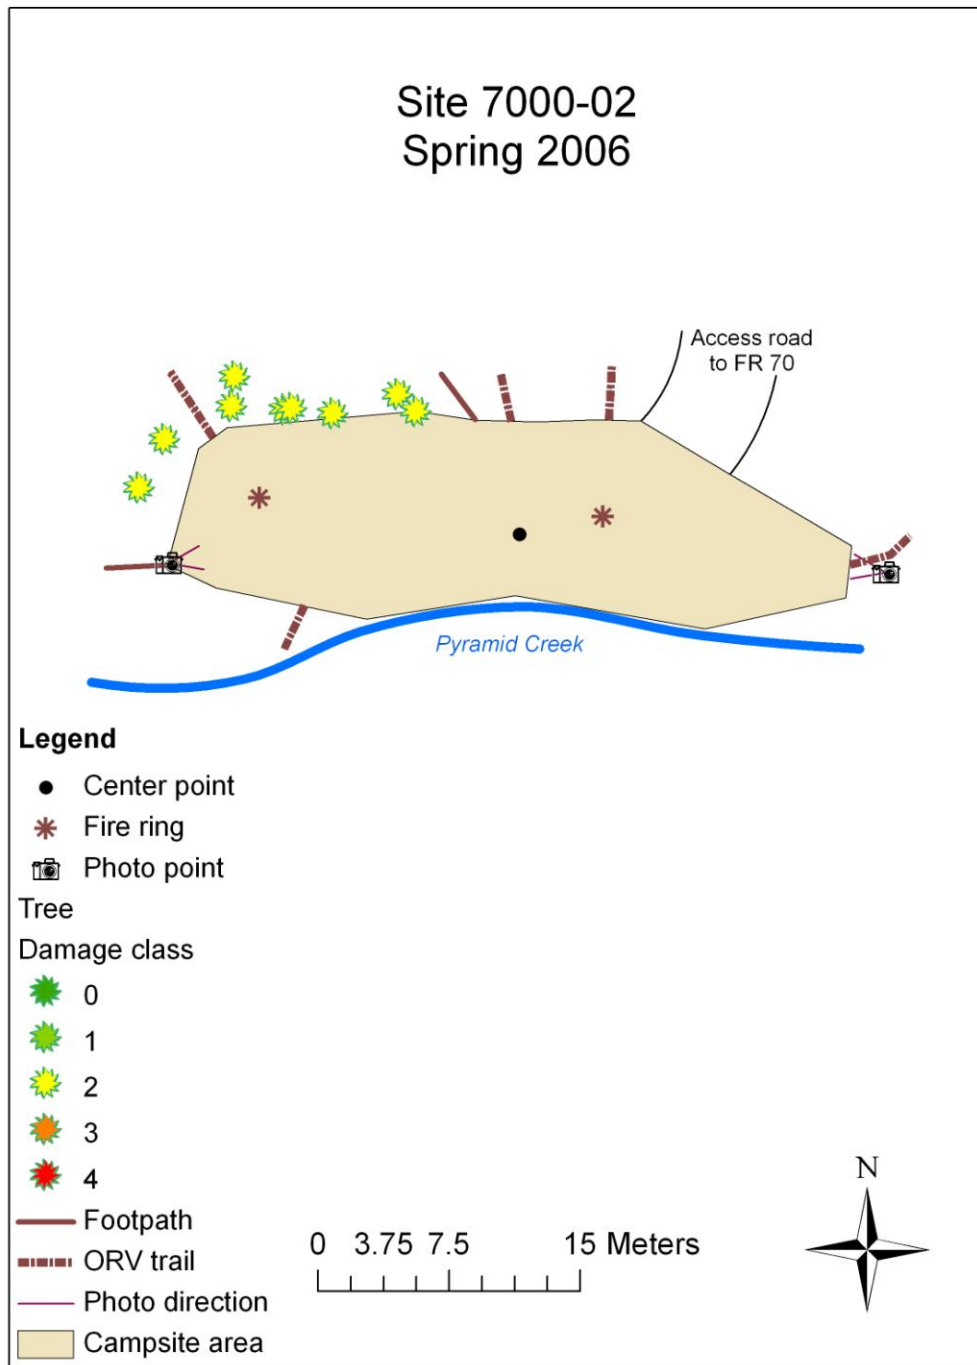
Figure 45. Map of campsite #7000-02, spring 2006.

Figure 46. Map of campsite #7000-02, fall 2006.

Campsite 7000-02 (Figures 45 and 46) consists of a large parking area on the FR 70 shoulder and a separate, large, sunny campsite immediately adjacent to Pyramid Creek. The entire southern boundary of the campsite is defined by the Pyramid Creek shoreline. Satellite sites are located on a higher terrace to the north. The site receives heavy use by RV and tent campers.

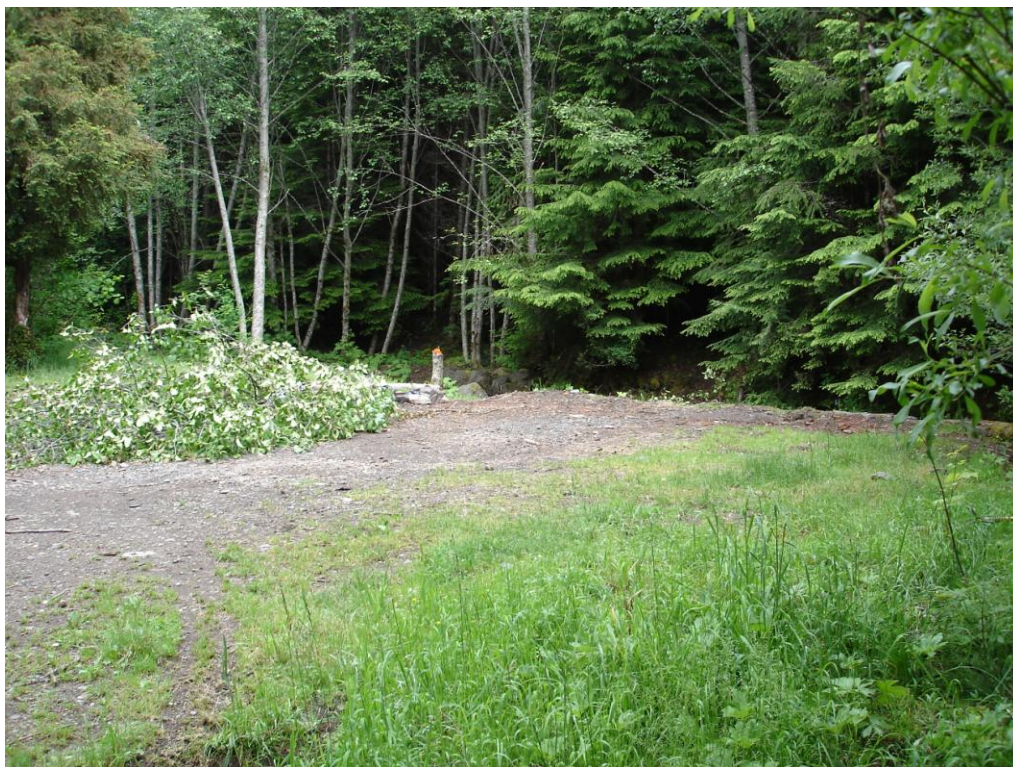
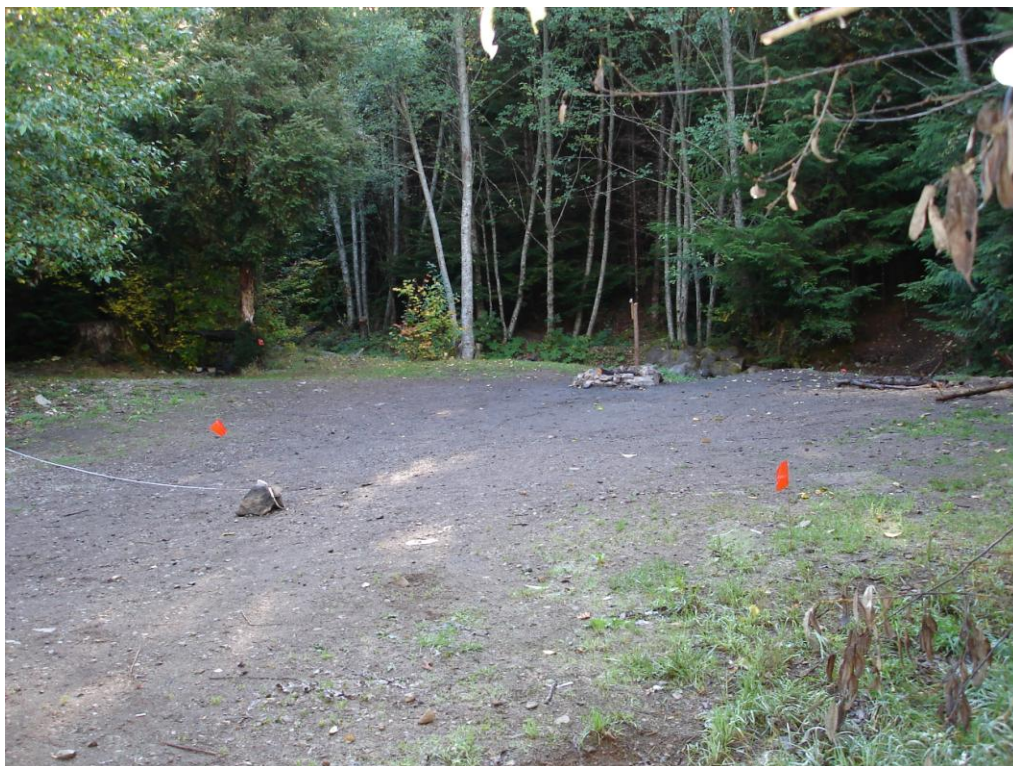
Figure 49. Spring (top) and fall 2006 photos of site 7010-02. Note seasonal vegetation changes.

returning in the fall, however, grasses and forbs had been trampled or had entered dormancy for the dry late summer/early fall season. Regardless of the season in which monitoring data collection occurs in the future, managers should assure that the sites are measured at a consistent time of year to avoid errors stemming from seasonal vegetation fluctuations (Hall, 2001).

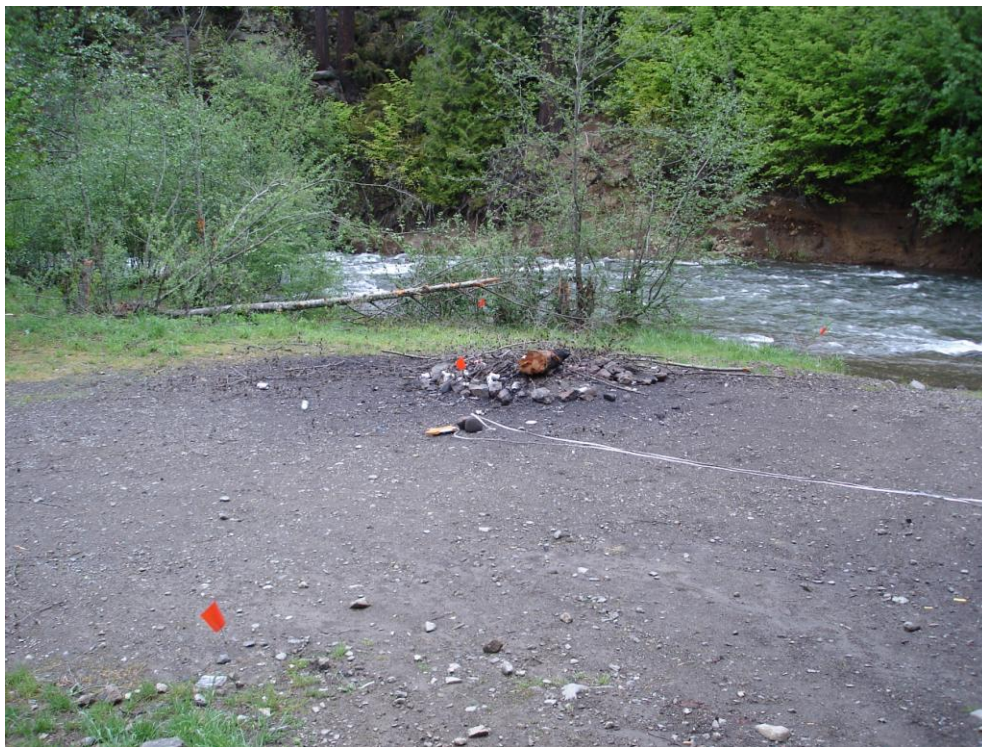
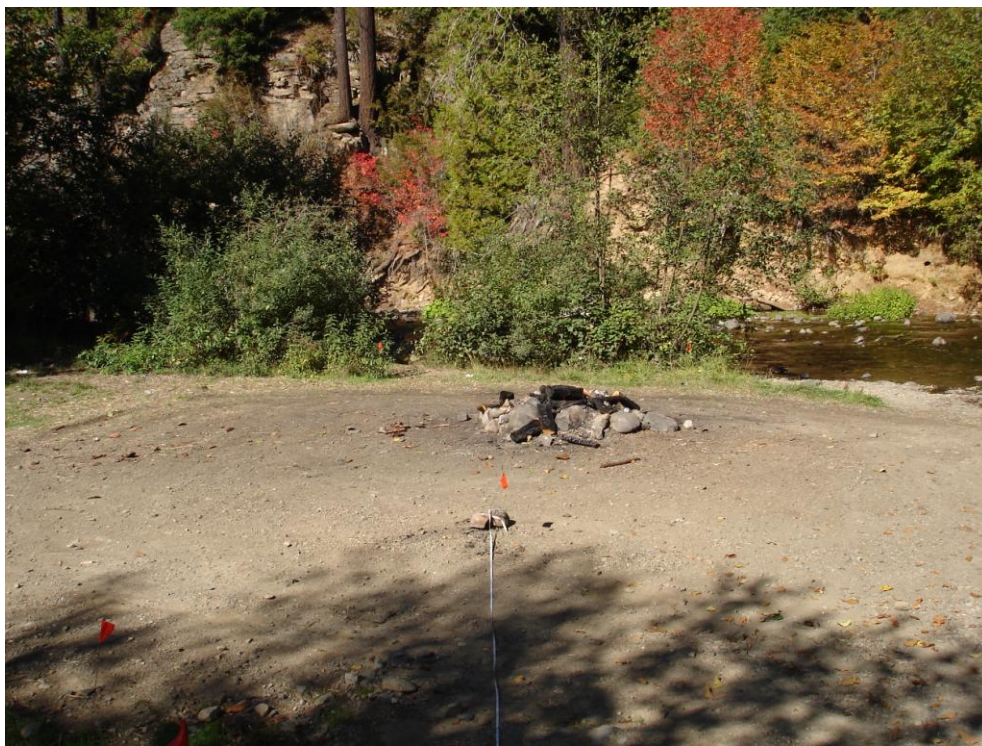
Figure 50. Spring (top) and fall 2006 photos of site 7030-04.

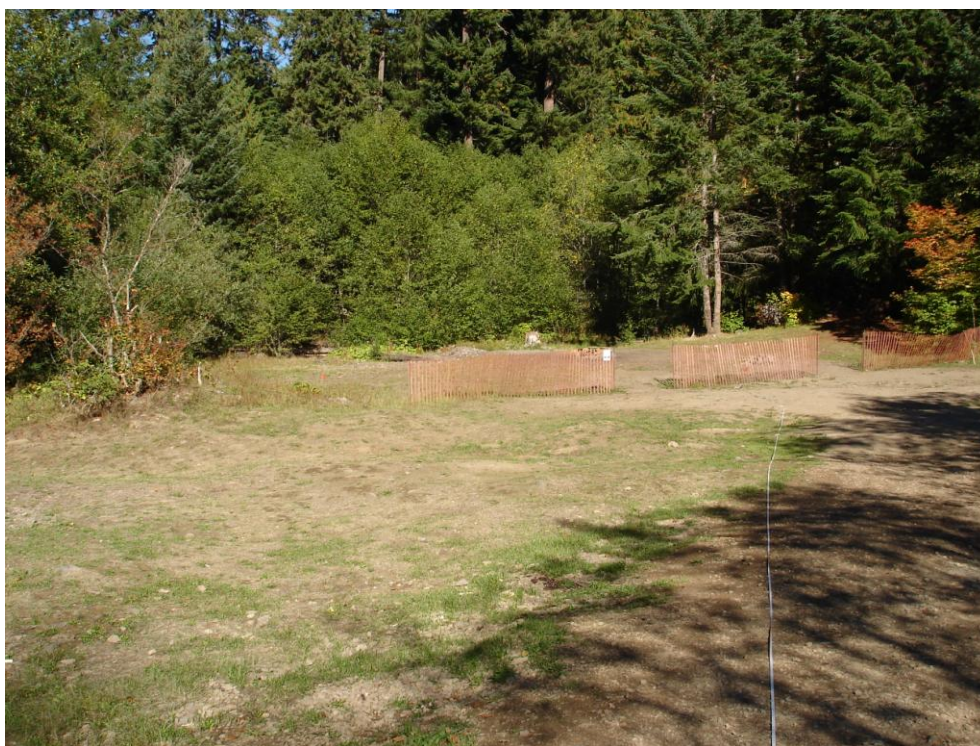
Figure 51. Spring (top) and fall 2006 photos of site 7031-04. Note installed fence and sign.

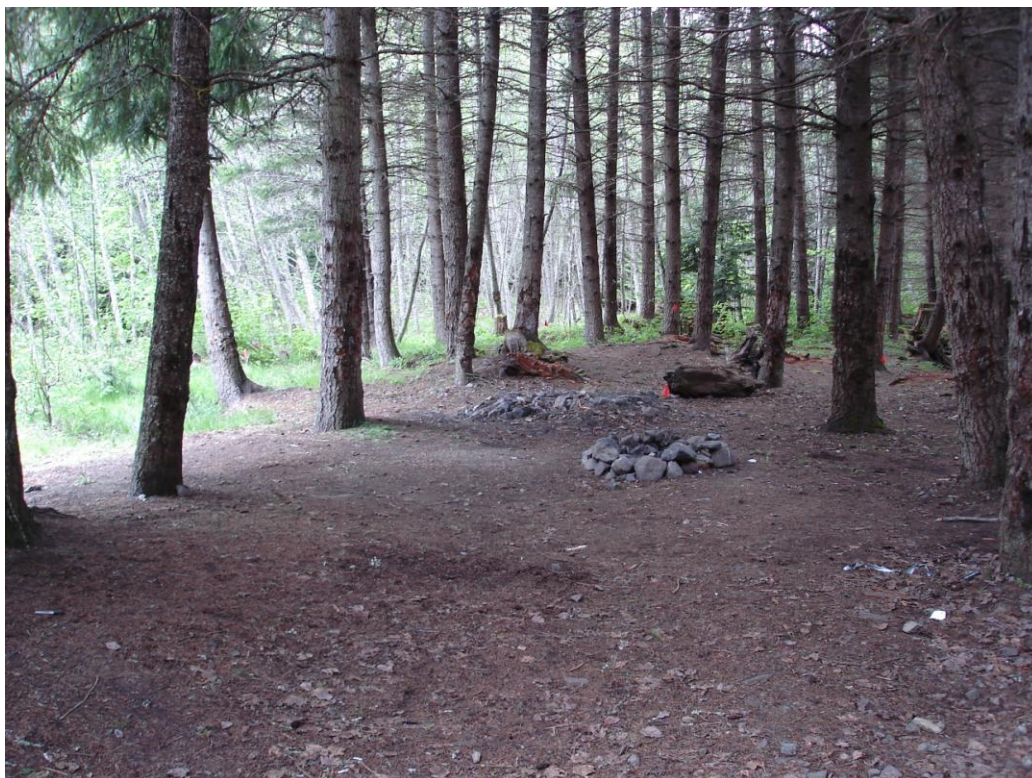
Figure 52. Spring (top) and fall 2006 photos of site 7000-01.
