HISTORICAL CHANGES IN RIPARIAN VEGETATION AND CHANNEL
MORPHOLOGY ALONG THE LOWER ENTIAT RIVER VALLEY,
WASHINGTON: IMPLICATIONS FOR STREAM
RESTORATION AND SALMON RECOVERY

A Thesis

Master of Science

Resource Management

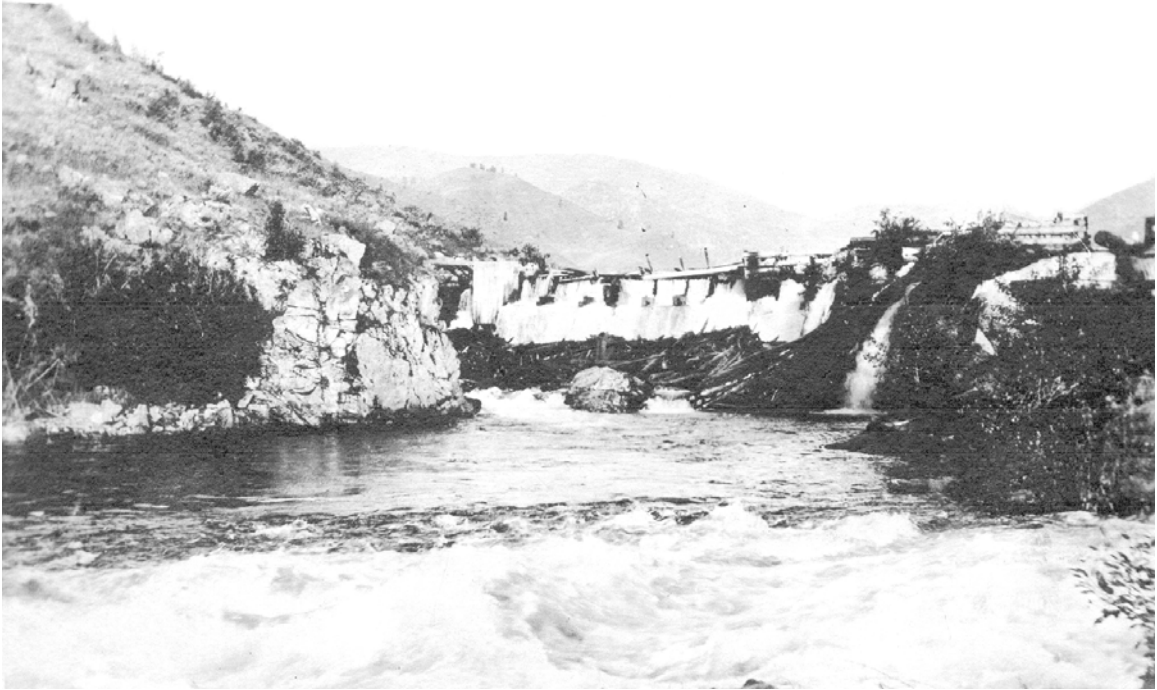
Figure 9. Early postcard depicting the dam at “Gray’s Mill” near the mouth of the Entiat River, ca. 1916. This particular dam is likely the last incarnation of the dam and mill activity that began in 1888 at this location (photographer unknown).

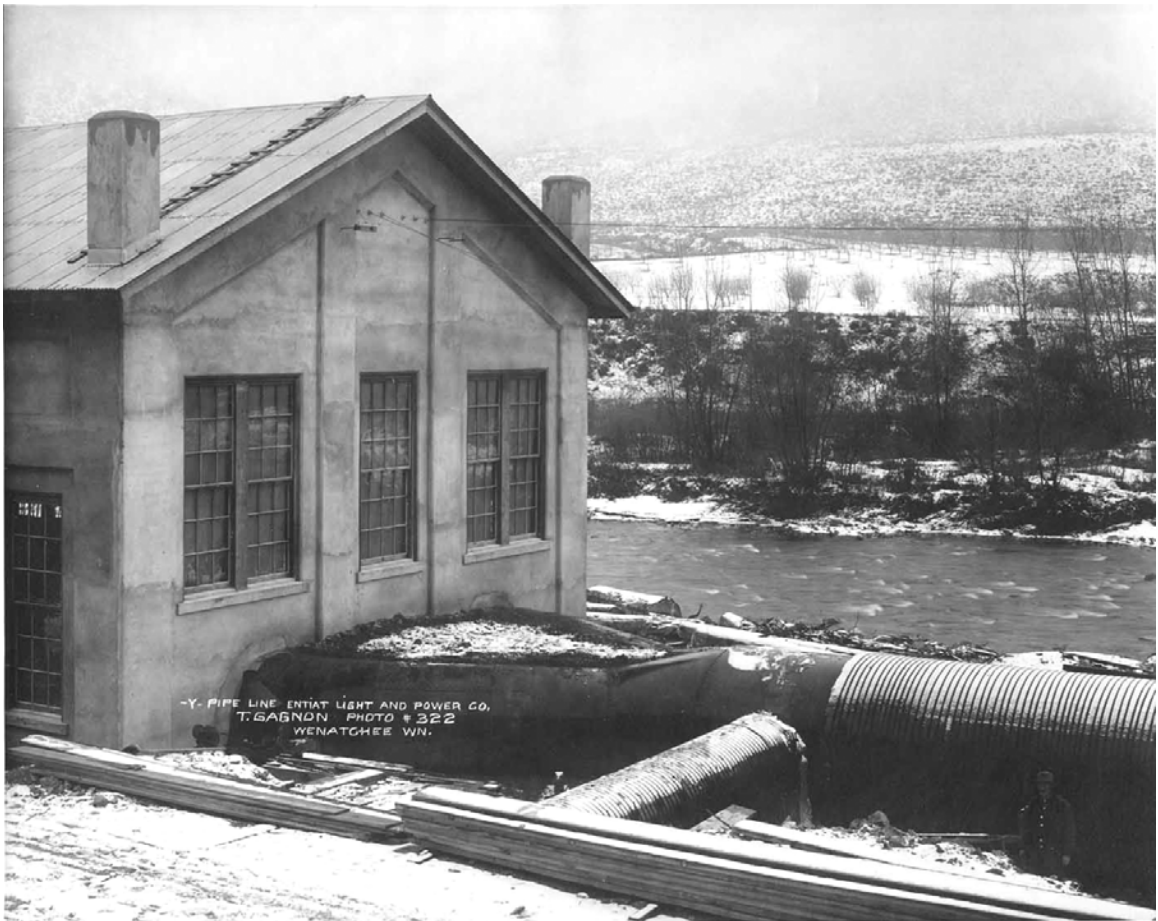
Figure 10. Power plant built by the Entiat Light and Power Company near river mile one, ca. 1910. The large pipe in the photograph funneled water impounded by a three-foot high dam located more than a mile upstream (Photograph courtesy of the Wenatchee Valley Museum and Cultural Center, Chamber Collection, #86-24-90).

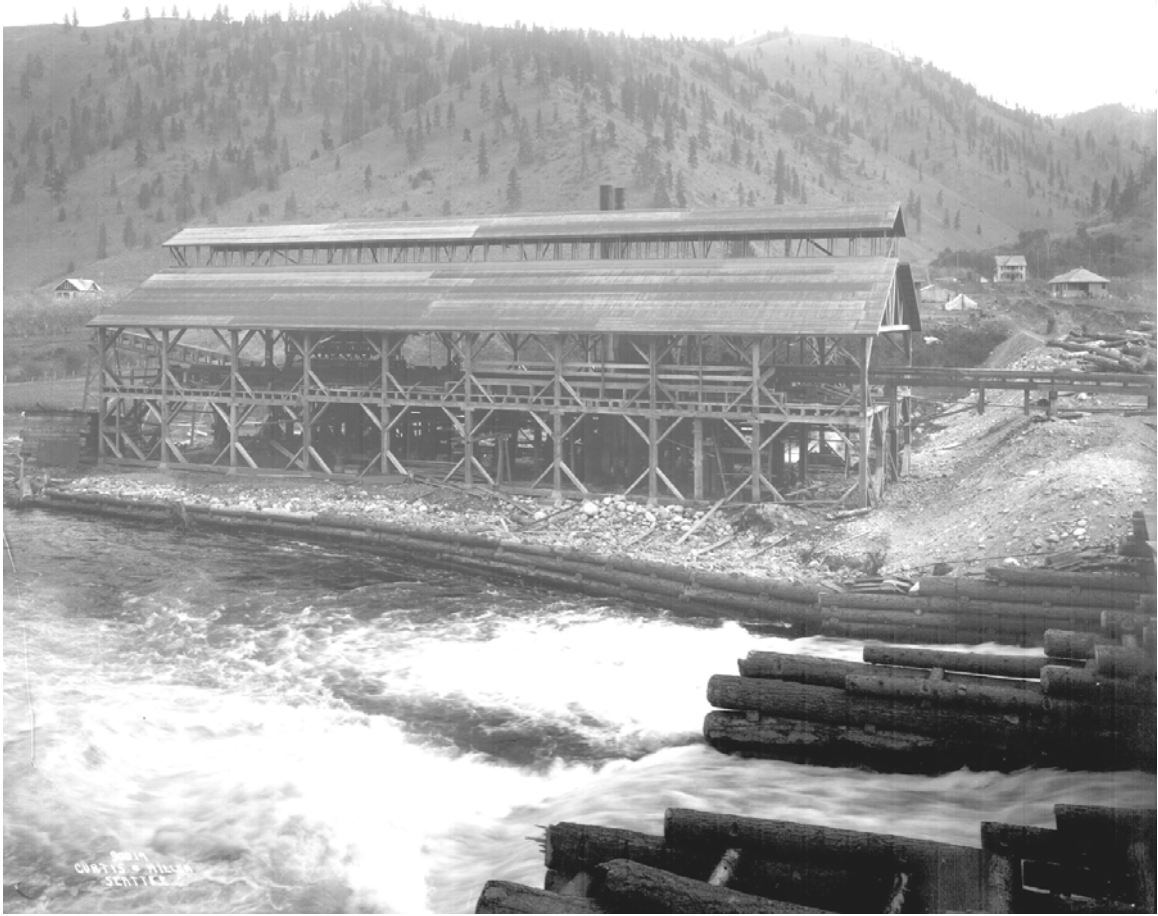
Figure 11. The Kellogg sawmill near Mills Canyon, 1914. Clearly, the Entiat River was heavily modified in this section. The millpond/reservoir behind the dam held vast quantities of timber and was hundreds of feet long (Photograph courtesy of the Washington State Historical Society, Asahel Curtis Collection, #30019).

Entiat River and was constructed out of logs (figure 11). The mill was closed in 1917 after it burned, but the dam remained an obstacle to fish passage until 1932, when sportsman dynamited a hole partially through the dam to improve fish migration (U.S. Bureau of Fisheries 1937; Bryant and Parkhurst 1950). During its short existence, the mill processed and stored considerable volumes of timber as evident by its large millpond

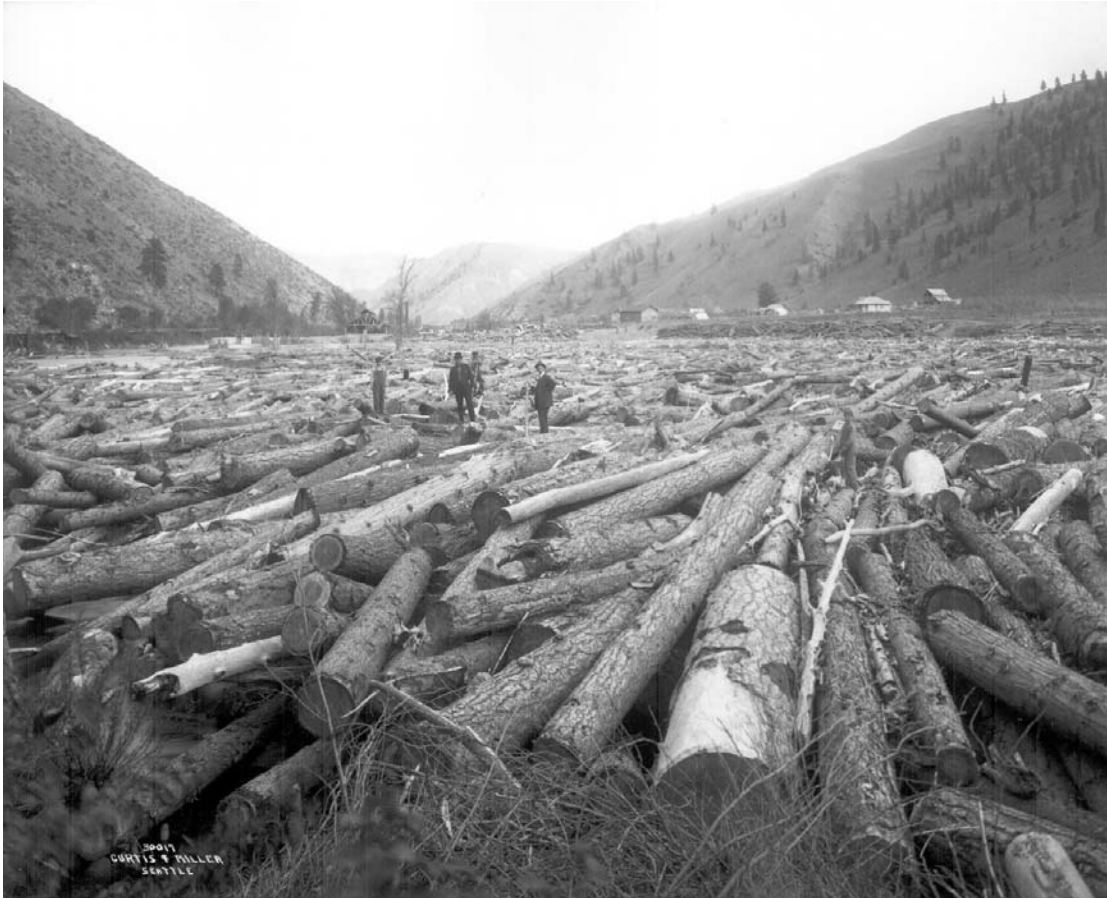
Figure 12. Downriver view near Mills Canyon in 1914. The large stacks of timber are ready for processing at the Kellogg Mill (Photograph courtesy of the Washington State Historical Society, Asahel Curtis Collection, #30017).

beyond the dam (figure 12). Logs were floated down the river to the millpond from logging sites far upstream and upvalley (Long 2001).

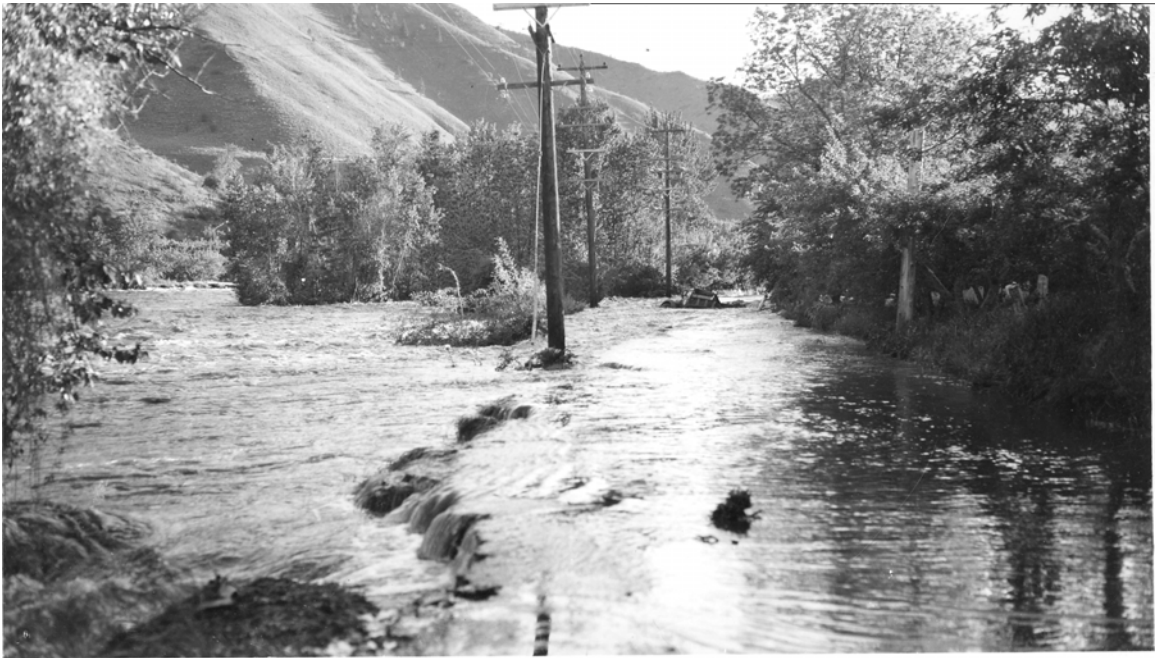
Figure 13. Flooding along the lower Entiat River Valley, 1948. (Photograph courtesy of the Wenatchee Valley Museum and Cultural Center, Gamble Collection, #83-28-9).

In the Entiat River Valley, the flood left at least 50 people homeless and caused hundreds of thousands of dollars in damage (figures 13-14). Ardenvoir, the Stanley

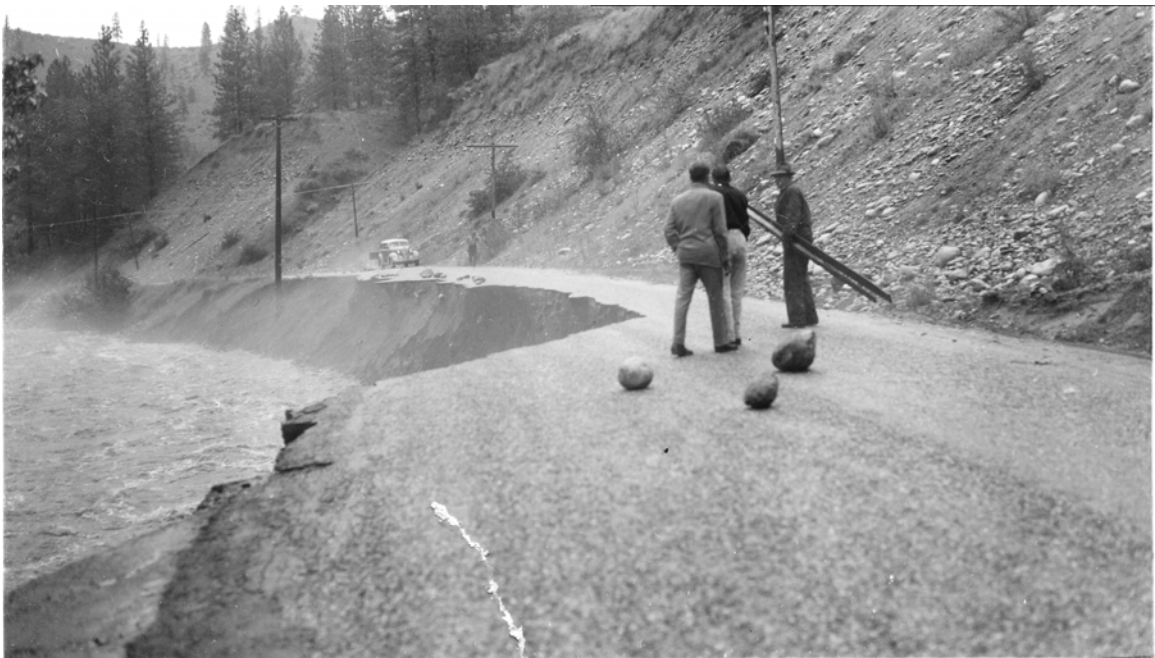
Figure 14. Flood damage to the Entiat River Road near the Stanley Grade, 1948. (Photograph courtesy of the Wenatchee Valley Museum and Cultural Center, Gamble Collection, #83-28-7).

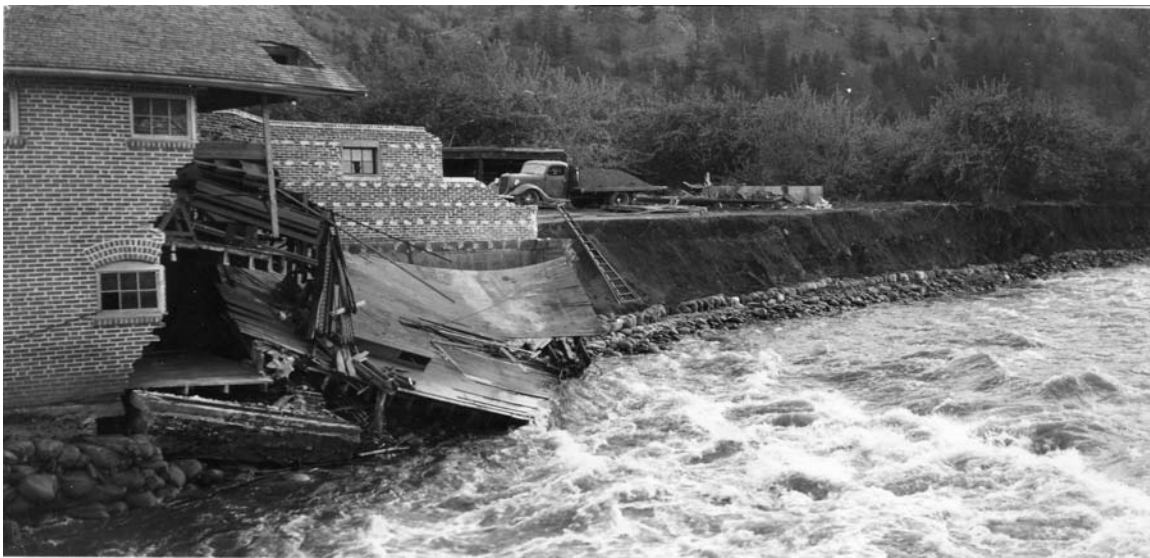
Figure 23. Pre-existing rock riprap bank protective structure located above river mile four during the 1948 flood (Photograph courtesy of the Wenatchee Valley Museum & Cultural Center, Gamble Collection, #83-28-10).

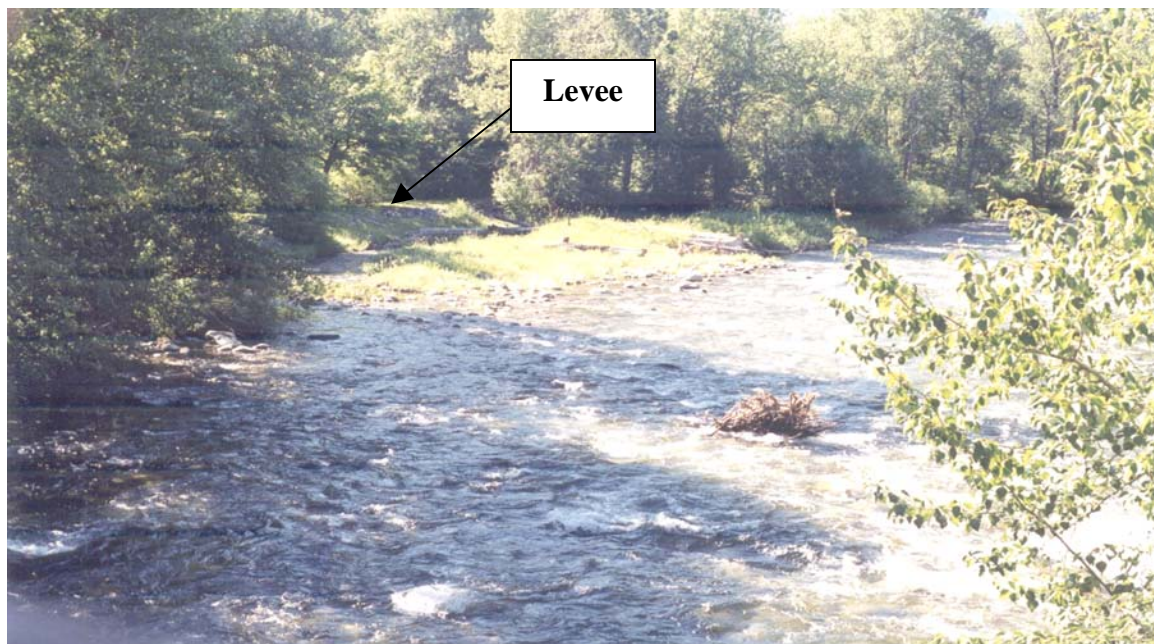
Figure 24. Present-day view of an old levee feature located downstream of the Roaring Creek Bridge. Most of the levee and bank protection features are difficult to discern from the landscape because of their inconspicuous size and the fact that many are now covered by dense vegetation.
