Assessing the Effects of Instream Large Wood on Floodplain Aquifer Recharge and Storage at Indian Creek, Kittitas County, Washington, USA

A Thesis
Presented to
The Graduate Faculty
Central Washington University

In Partial Fulfillment
of the Requirements for the Degree
Master of Science
Geological Sciences

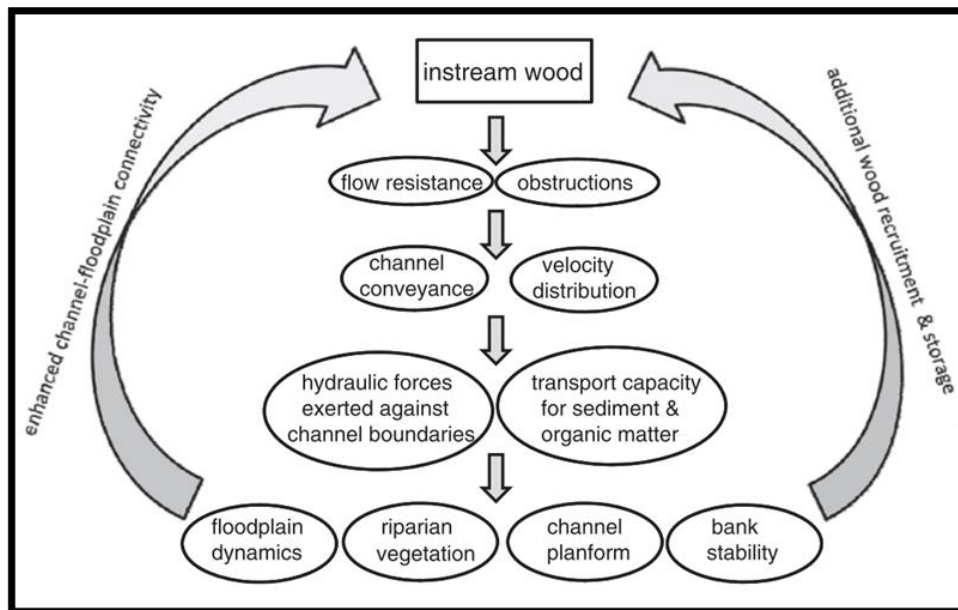
Figure 1. Instream wood diagram of the effects of instream wood on channel complexity from Wohl, (2013).

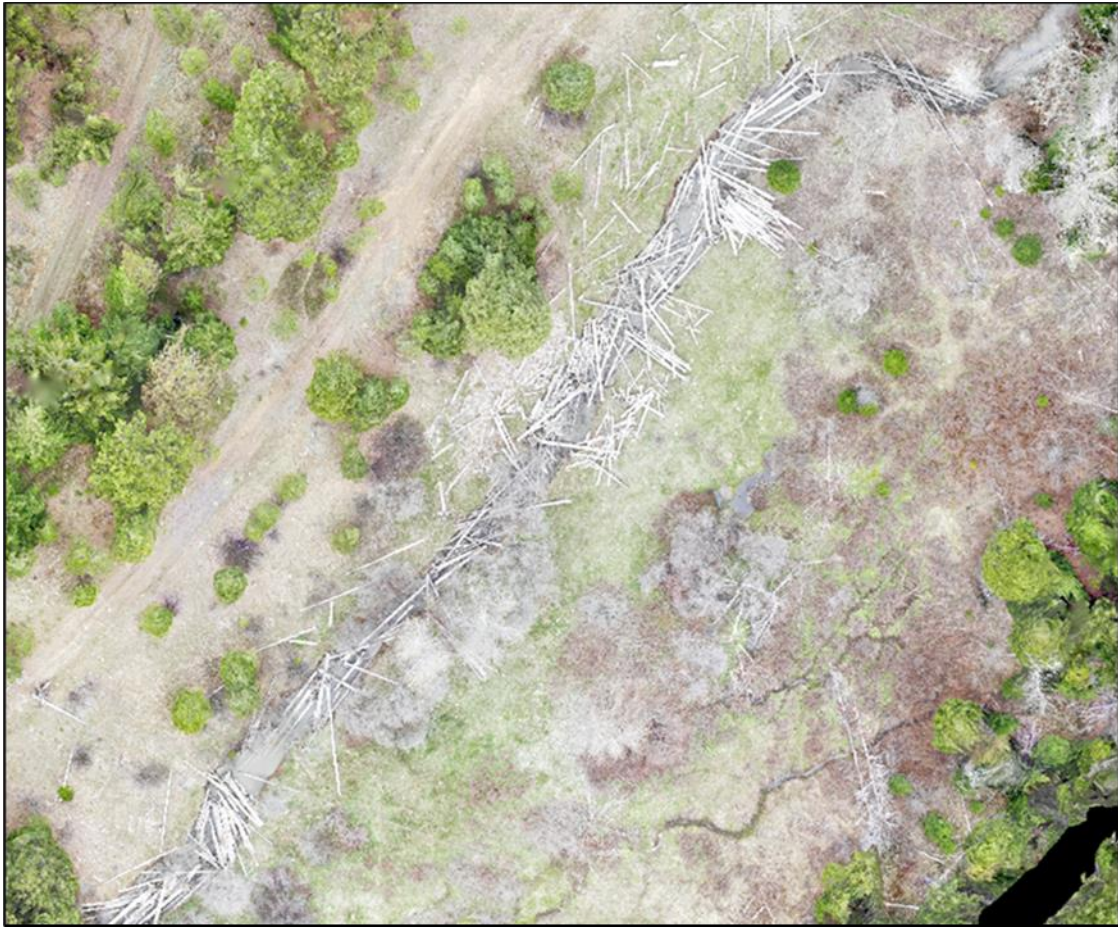
Figure 4. Aerial photo of instream large wood restoration of Indian Creek near North Fork Teanaway road just upstream from the DOE gauge (Figure 5A). (Image credit: Isaac Mitchell)

Using the “add obstructions” tool in HEC-RAS geometry editor, obstructions were placed throughout the channel of each cross section based on where the wood was observed on the 2019 drone imagery (Figure 4). Obstructions were placed only in the stream channel based on the presence of wood according to what is visible in the aerial imagery. The tool builds vertical obstructions at the desired width. The density of obstructions placed within each cross-section was chosen based on the results from Spreitzer et al., (2020), which showed a common average porosity of large wood jams to be approximately 66%. To simulate the density of wood piles, the obstructions were built as vertical blocks of varying height and thickness until the channel reached an approximate fill of 33%.

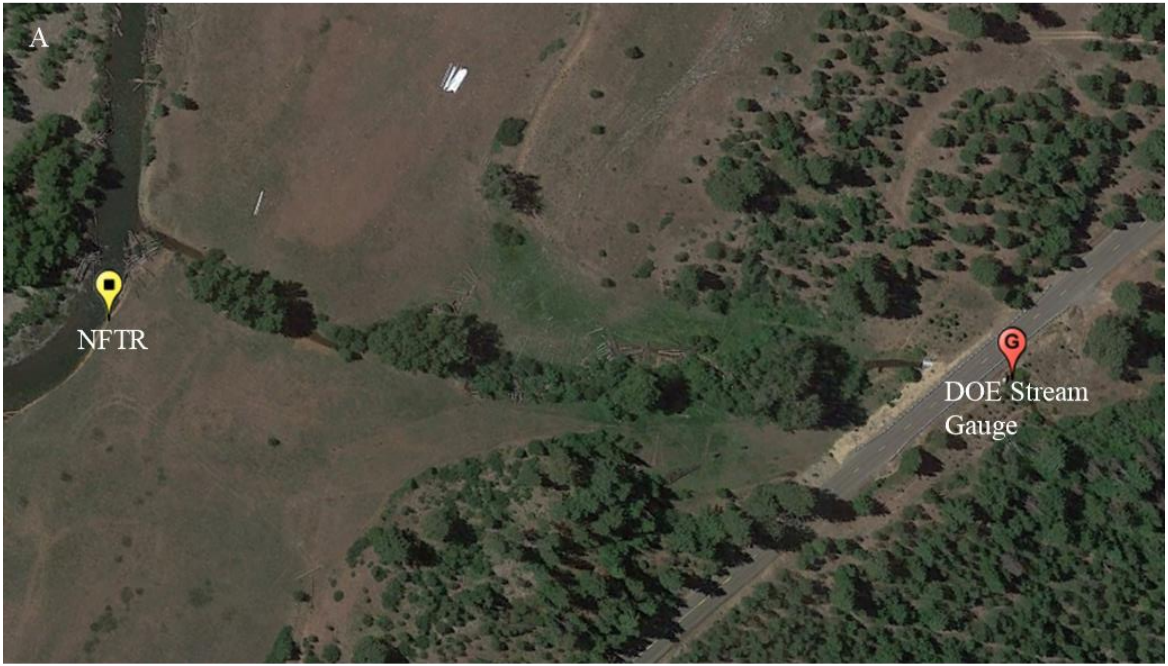
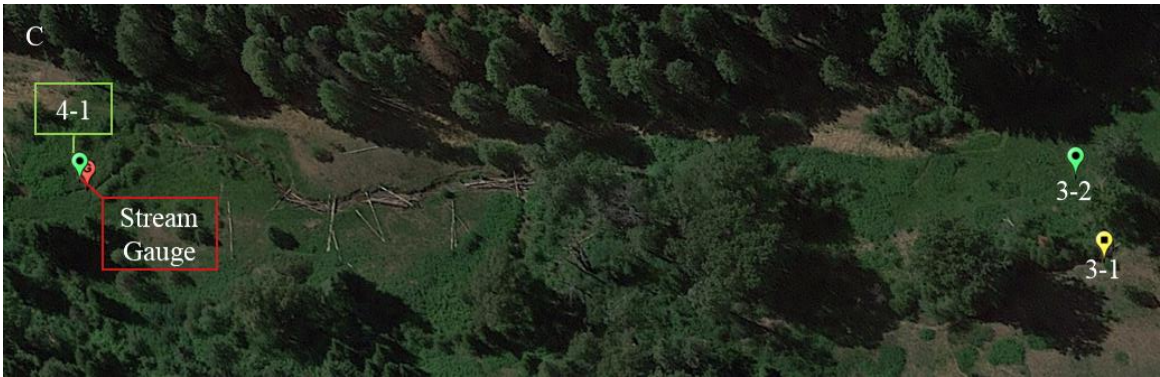
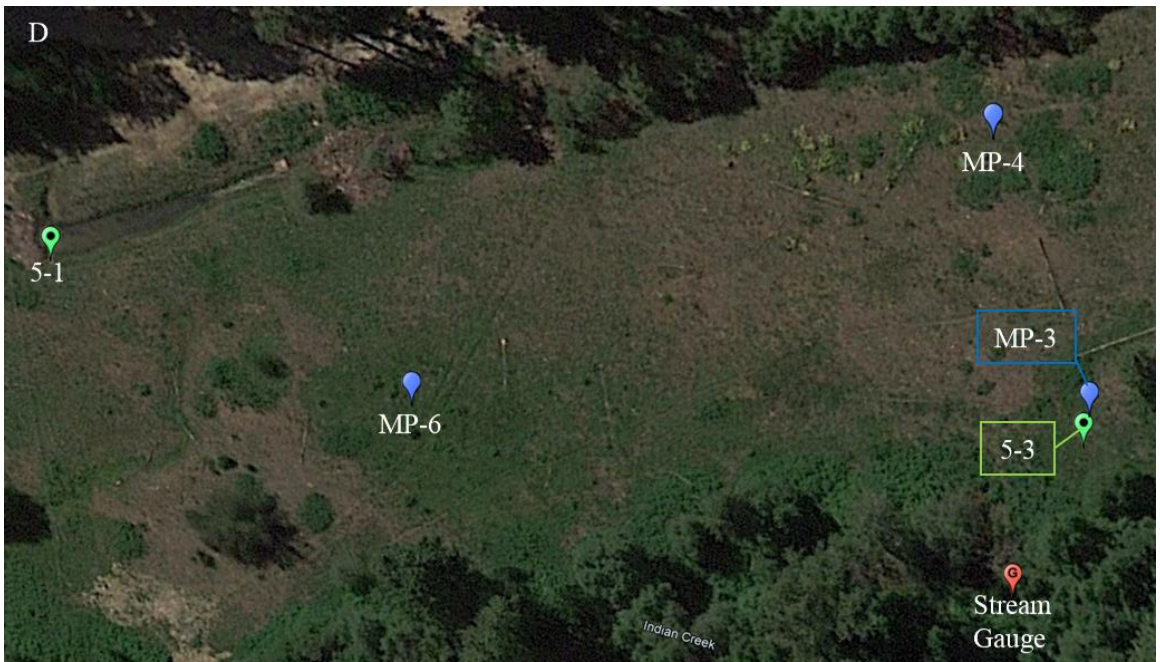
Figure 5. Study area of Indian Creek. Image A shows the downstream reach near the North Fork Teanaway River. Image B shows the downstream well cluster. Image C shows the middle reach. Image D shows the upstream reach and well cluster. Blue markers represent the groundwater monitoring wells. Green markers represent the floodplain stratigraphy sites. Yellow markers represent the stream bank stratigraphy sites. Red markers represent stream gauges.

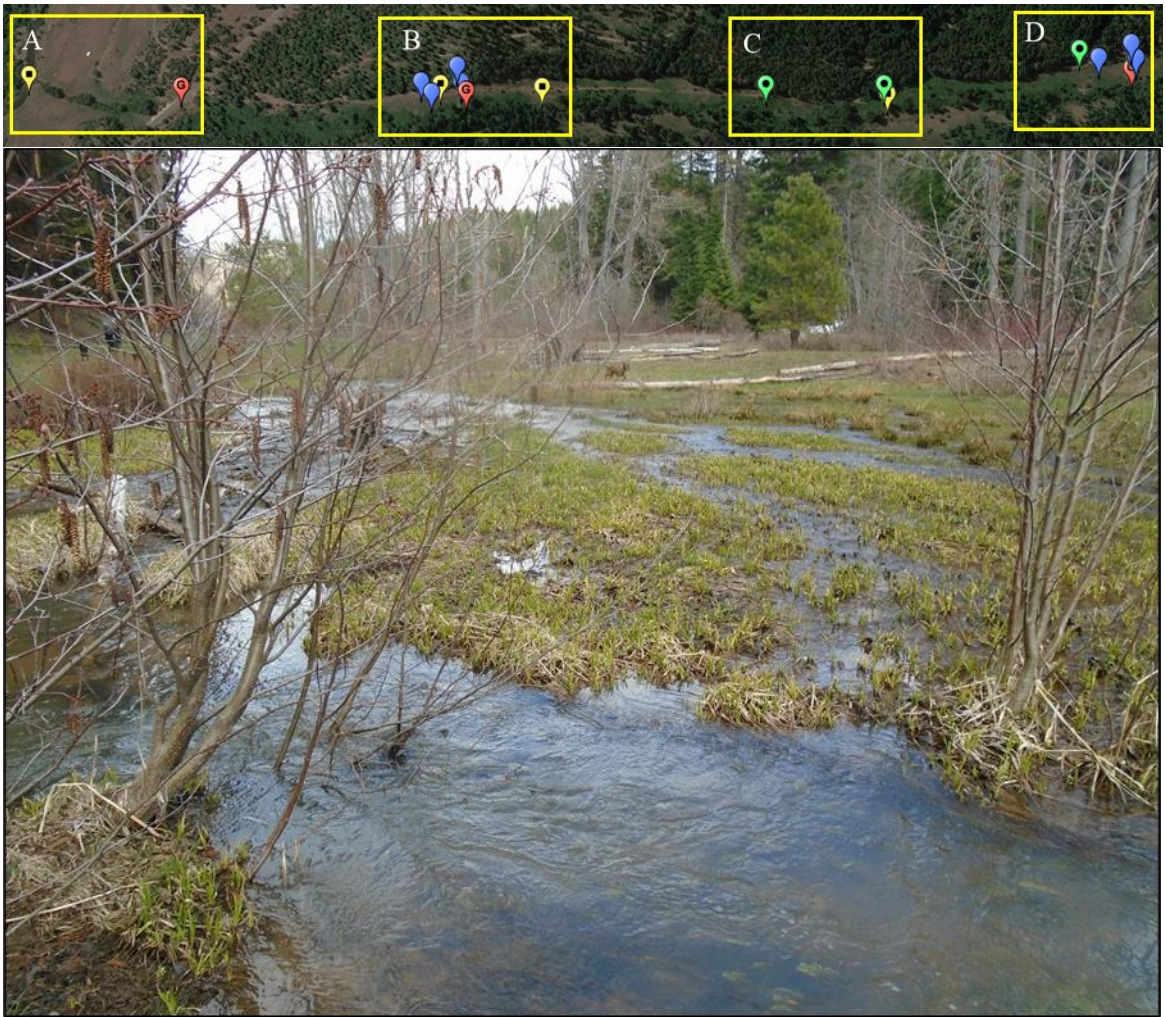
Figure 7. Floodplain inundation of surface water during peak discharge. 04/17/2020. The floodplain just downstream of the gauge in Image C. Image by Stephen Bartlett

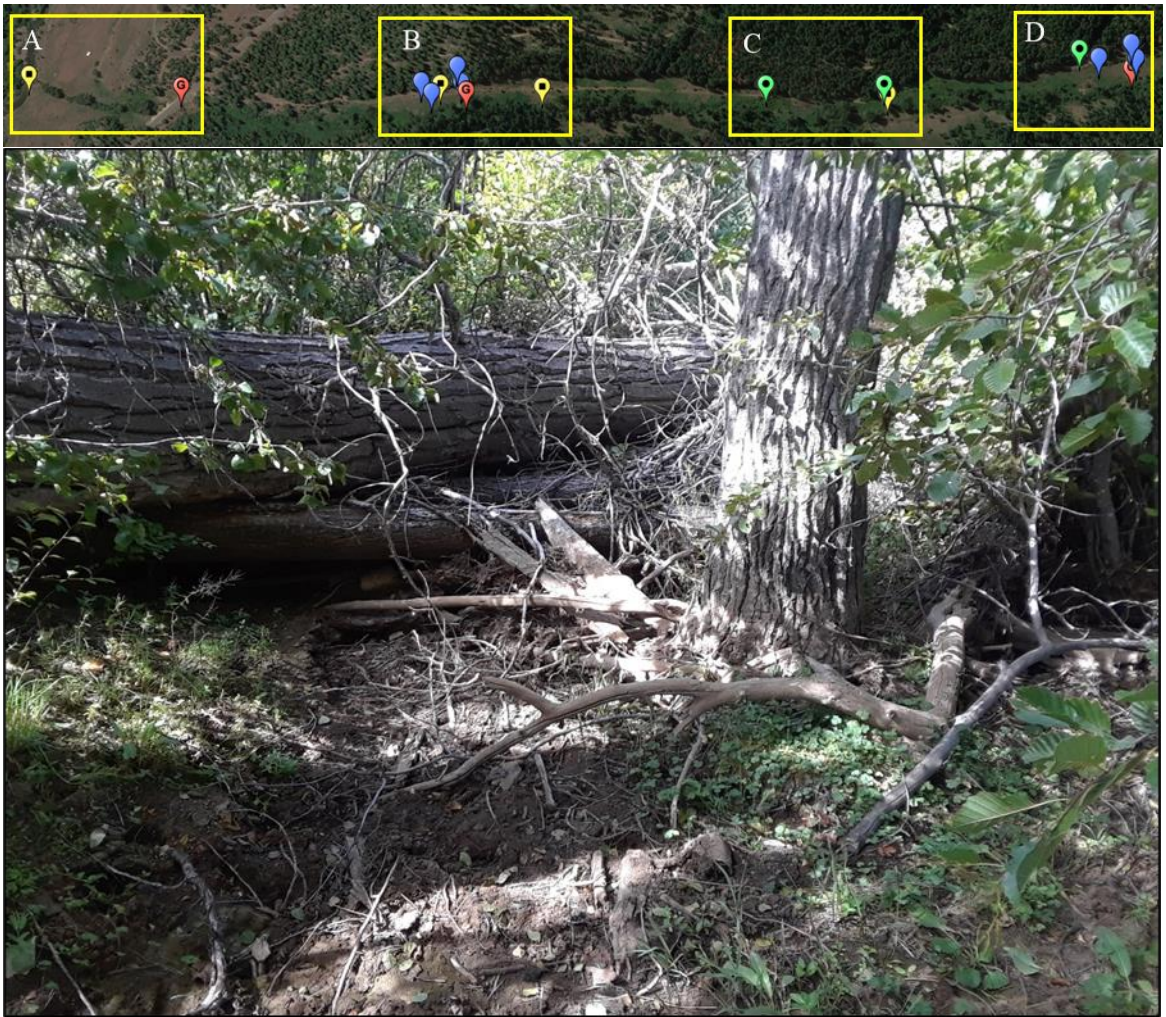
Figure 8. Dry stream channel at Indian Creek. Looking upstream at an instream large wood jam in the Indian Creek channel during summer. Located near the mouth of Indian Creek in Image A. Most of the stream channel is dry. 8/22/2020. Image by Stephen Bartlett

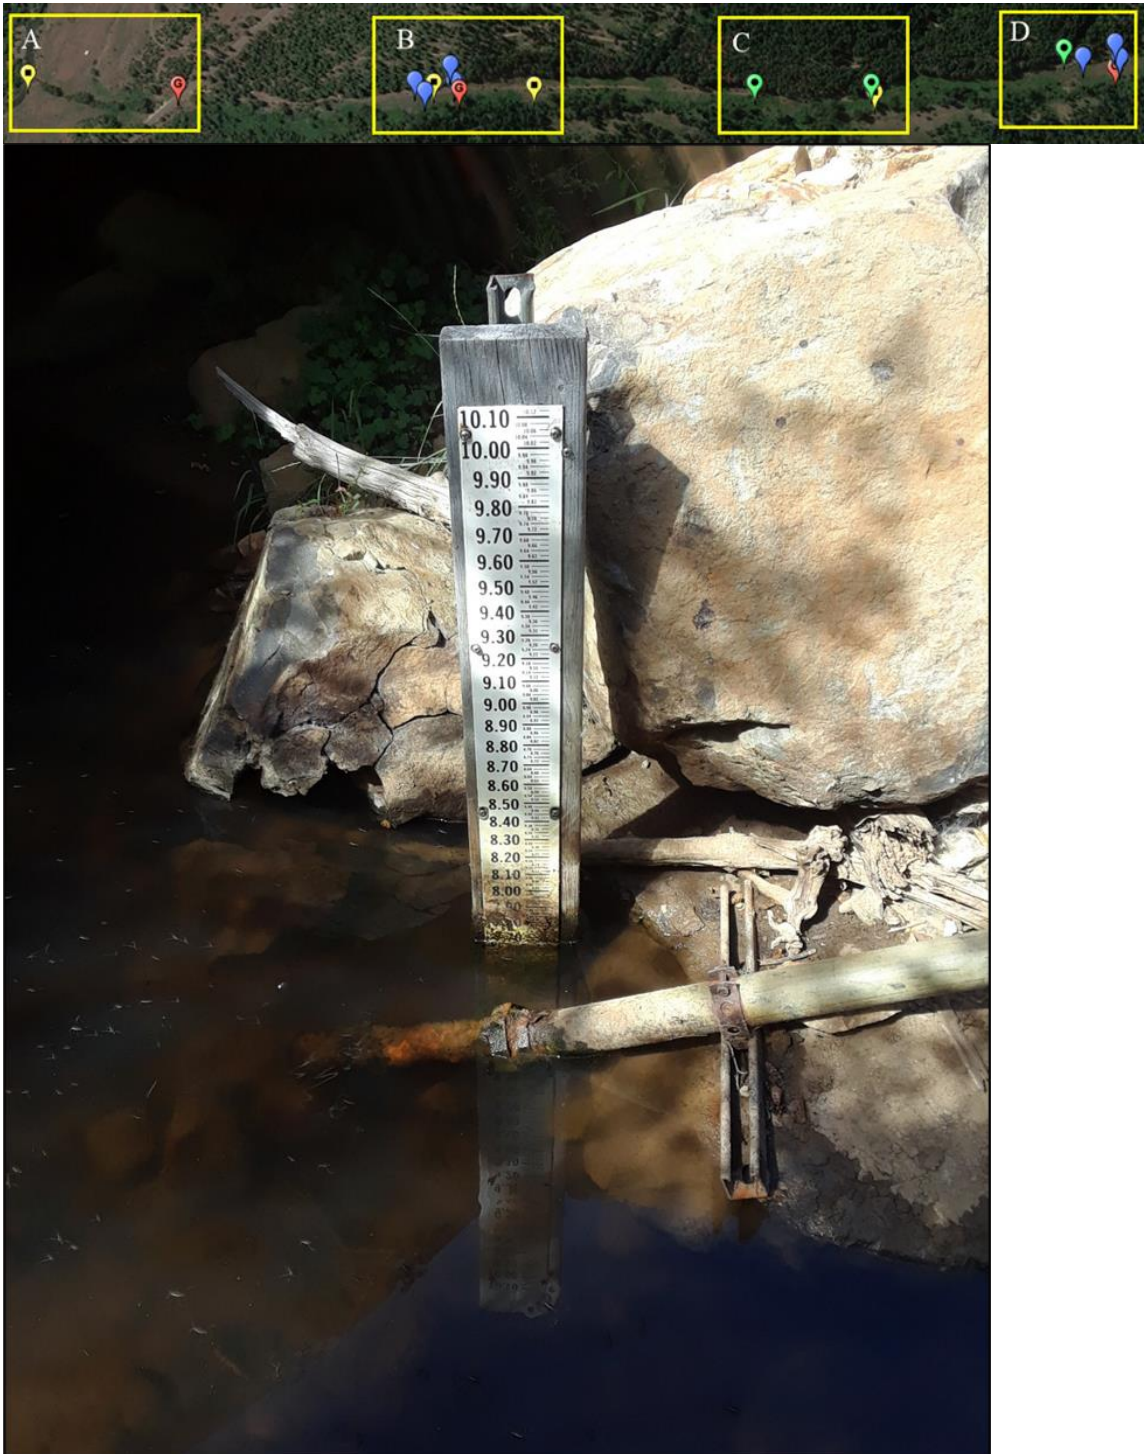
Figure 9. Photograph of Department of Ecology stream gauge. Stagnant water on 8/22/2020. Image by Stephen Bartlett

Most of the precipitation at Indian Creek falls between October and March (Prism Climate Group). Stream discharge rises rapidly in the early spring, usually peaking between early April and early May (Washington Department of Ecology stream gauge ID: 39T060). During the peak discharge, in areas where the creek banks are less than 40-cm high, water overtops the banks and flows out onto the floodplain (Figure 7). Discharge then rapidly subsides in early May. The stream bed is mostly dry by the middle of summer (Figure 8), excluding some stagnant ponds and some reaches of trickling flow (Figure 9).

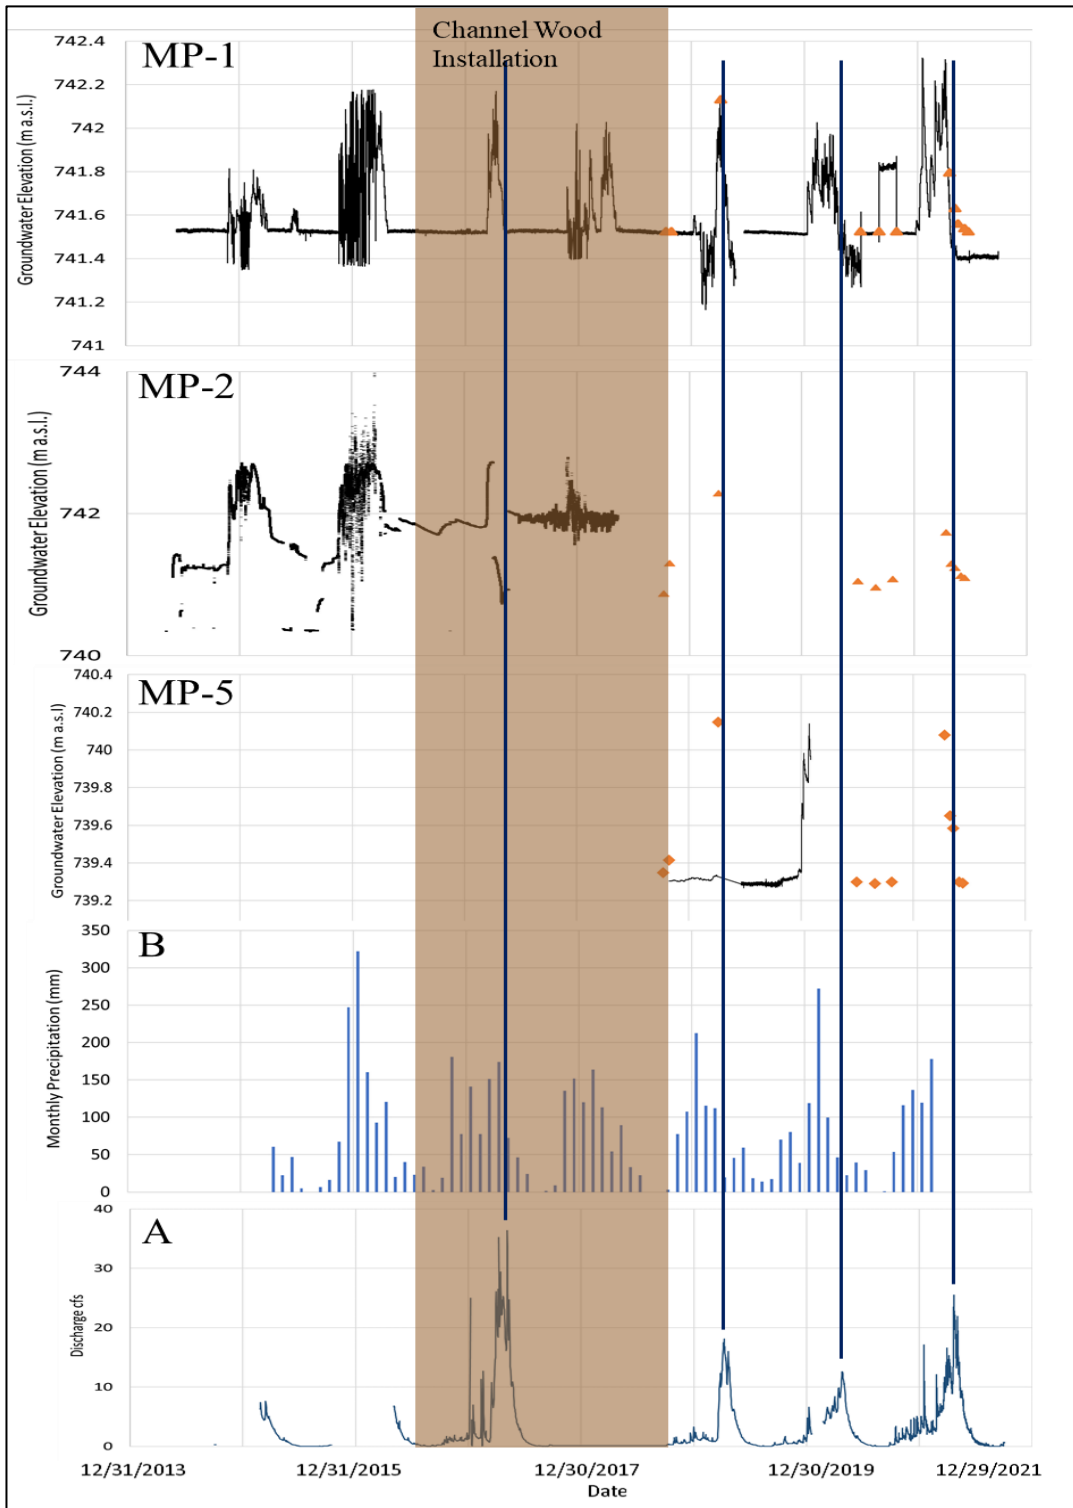
Figure 10. Pressure transducer data of the downstream well cluster compared to the stream discharge data (A) and the monthly regional precipitation data (B). Vertical brown shading represents the timeframe of wood installation. Vertical blue lines represent peak annual stream discharge. Orange diamonds represent manual measurements.

A comparison of GW elevations with stream discharge and monthly regional precipitation shows GW levels commonly increase with increases in precipitation (Figure 10 & 11). The data also show the GW levels are commonly in decline prior to peak stream discharge. In the spring of 2017, MP-1 was nearly dry by the time of the stream peak discharge (Table 4).

The peaks in groundwater levels are typically preceded by a peak in monthly precipitation. This pattern was observed in the data from all of the wells, as shown in Figures 10 & 11. Specifically, in November 2015 monthly precipitation reached 247 mm, the following month reached 322 mm. This period of above-average precipitation led to a large spike in the GW elevation at all of the wells that were in place at that time (Wells 1-4). Although precipitation remained high, above 75 mm per month through March, the water table of MP-4 declined rapidly at the end of December. It is likely that most of the precipitation that fell in January and February fell as snow and did not infiltrate into the subsurface until the melt in March. There is, however, a spike in January that may indicate that some of the precipitation fell as rain. The pressure transducer at MP-1 for this time shows many rapid fluctuations in water level and it is difficult to discern whether or not these are actual levels or erroneous readings.

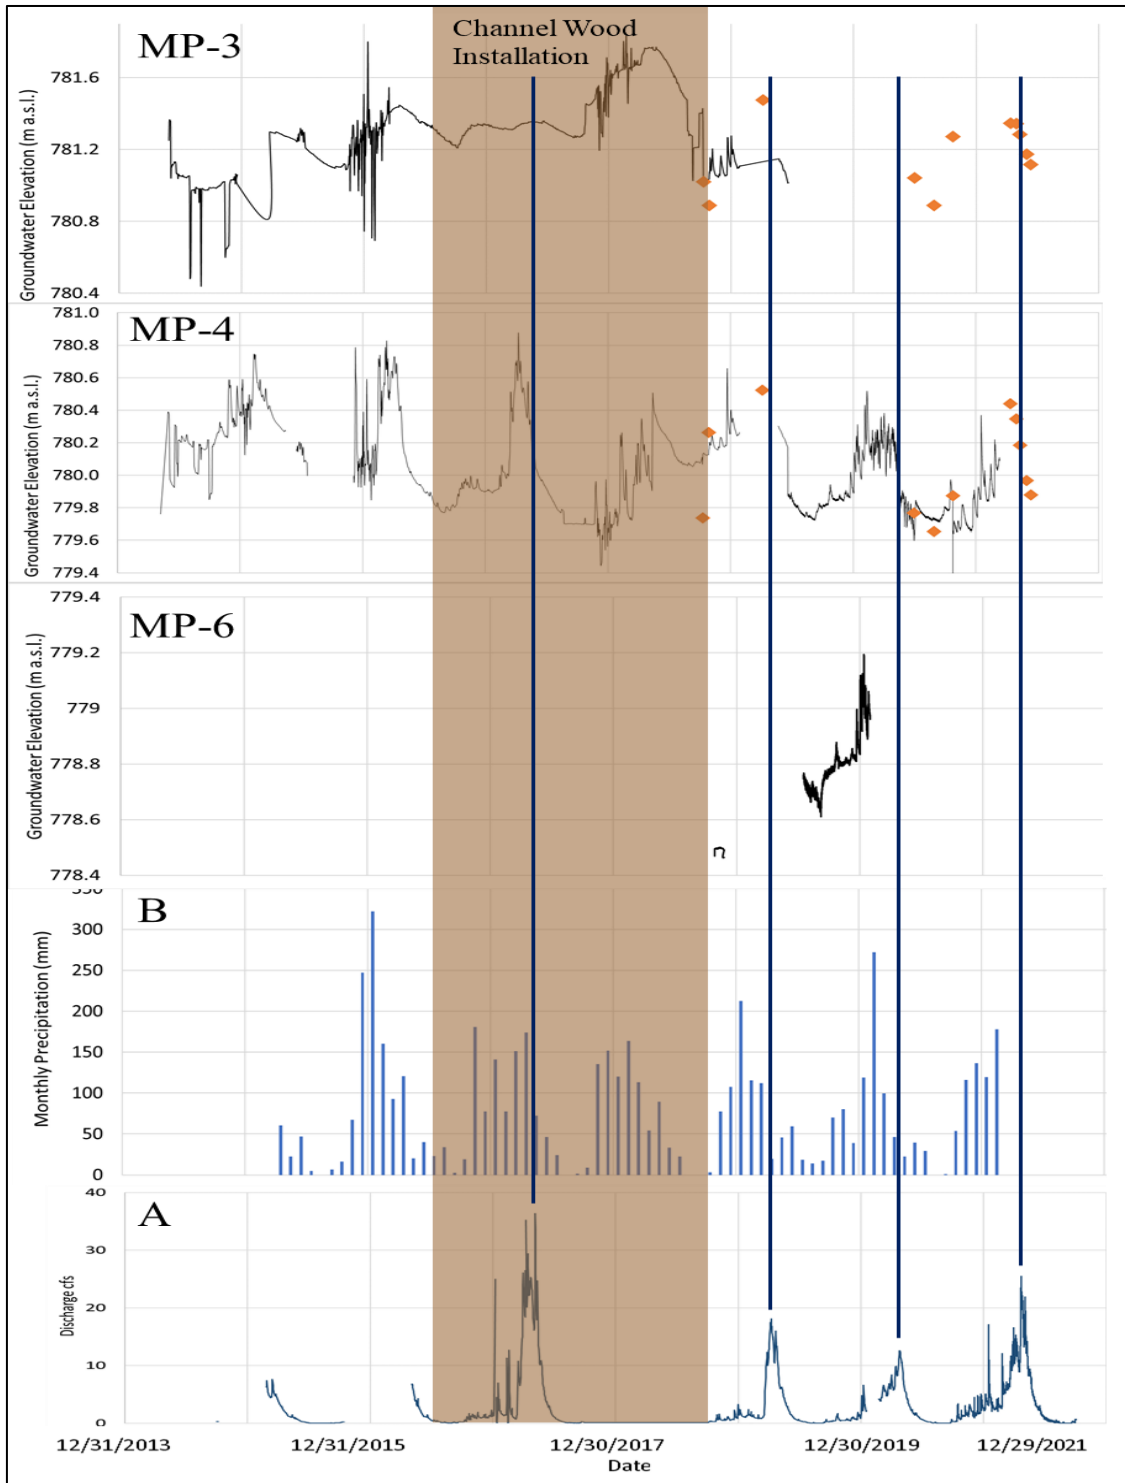
Figure 11. Pressure transducer data of the upstream well cluster compared to the stream discharge date (A) and the monthly regional discharge data (B). Vertical brown shading represents the timeframe of wood installation. Vertical blue lines represent peak stream discharge. Orange diamonds represent manual measurements.

Pressure transducer data from MP-2 shows the possible increase in summer base level GW level since monitoring began until the device malfunctioned in 2017 (Figure 11). The increase was noted by Boylan (2019) with the possibility that the increase is attributed to the LW installation. It is more likely that the increase to the base level GW is attributed to particularly high precipitation from May-August 2016 (Figures 10 & 11). Later manual measurements from MP-2 show that the increase in the minimum GW elevations during the summers from 2014-2017 did not persist through the subsequent years. The manual measurements show the summer base level returning to an elevation similar to when the transducer was installed in 2014. Precipitation during the summer months from 2017-2021 returned to low-moderate levels.

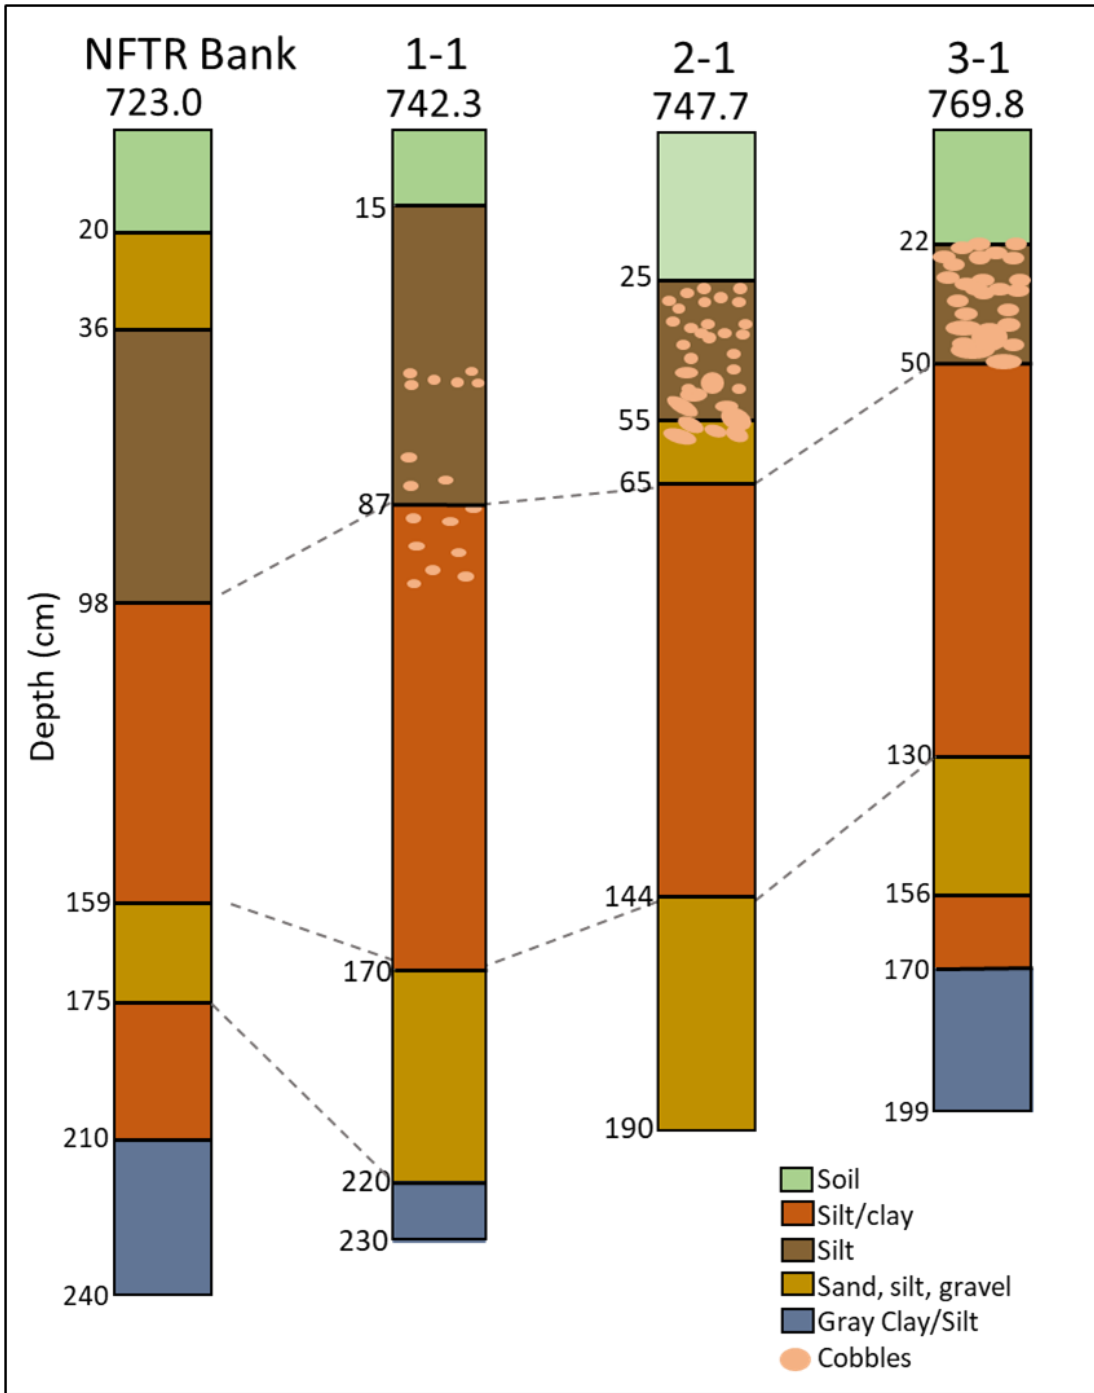
Figure 15. Streambank stratigraphy near the mouth of Indian Creek at the North Fork Teanaway River to 1.4 km upstream of Indian Creek. Locations are shown in Figure 5. Detailed descriptions of each site are in Appendix B.

become gray and red as the amount of clay increases. Sediment composition varies from site to site. Site 1-1 is mixed with fine-grained sand. Site 2-1 contains medium sand and gravel. Site 3-1 contains gravels up to 7 cm. The thickness of this zone at the NFTR and site 1-1 are both greater than 0.6 m. The zone thins upstream from 1-1 and the density and size of the gravel increases from up to 3 cm at site 1-1 to up to 7 cm at site 3-1.

The porosity estimates for this stratigraphic column do not necessarily reflect the entire floodplain. These samples were taken from the stream bank at section 1-1 and therefore are only useful for interpreting porosity for this area. The stratigraphy of the floodplain and composition of the zones vary throughout the entire reach (Figures 15 & 16).

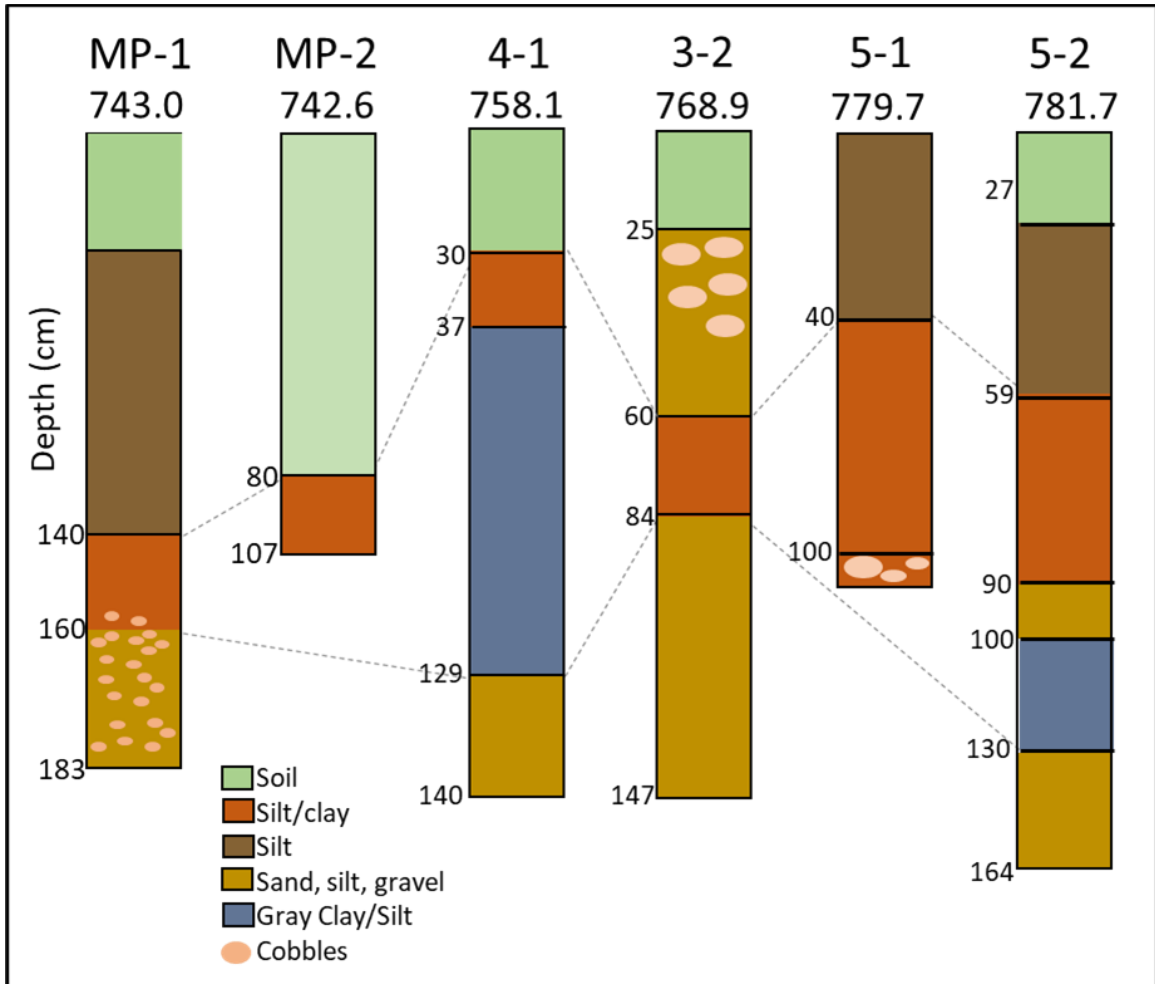
Figure 16. Floodplain stratigraphy. Locations can be seen in Figure 5. Detailed descriptions of the stratigraphy can be found in Appendix B.

The stratigraphy near MP-3 shows that the bottom of the well is in the sand and gravel zone above the gray clay (Figure 16). When manual water measurements were taken in both MP-3 and MP-6 during the summer and autumn the water has smelled like sewage. The foul-smelling water could mean that once the spring peak water levels have subsided there is a stagnant perched water table on top of the gray clay layer at these two wells, but not at MP-4. The difference at MP-4 is likely that the depth of the well penetrates through the gray clay into the sand and cobbles observed at site 3-1 and the NFTR streambank.

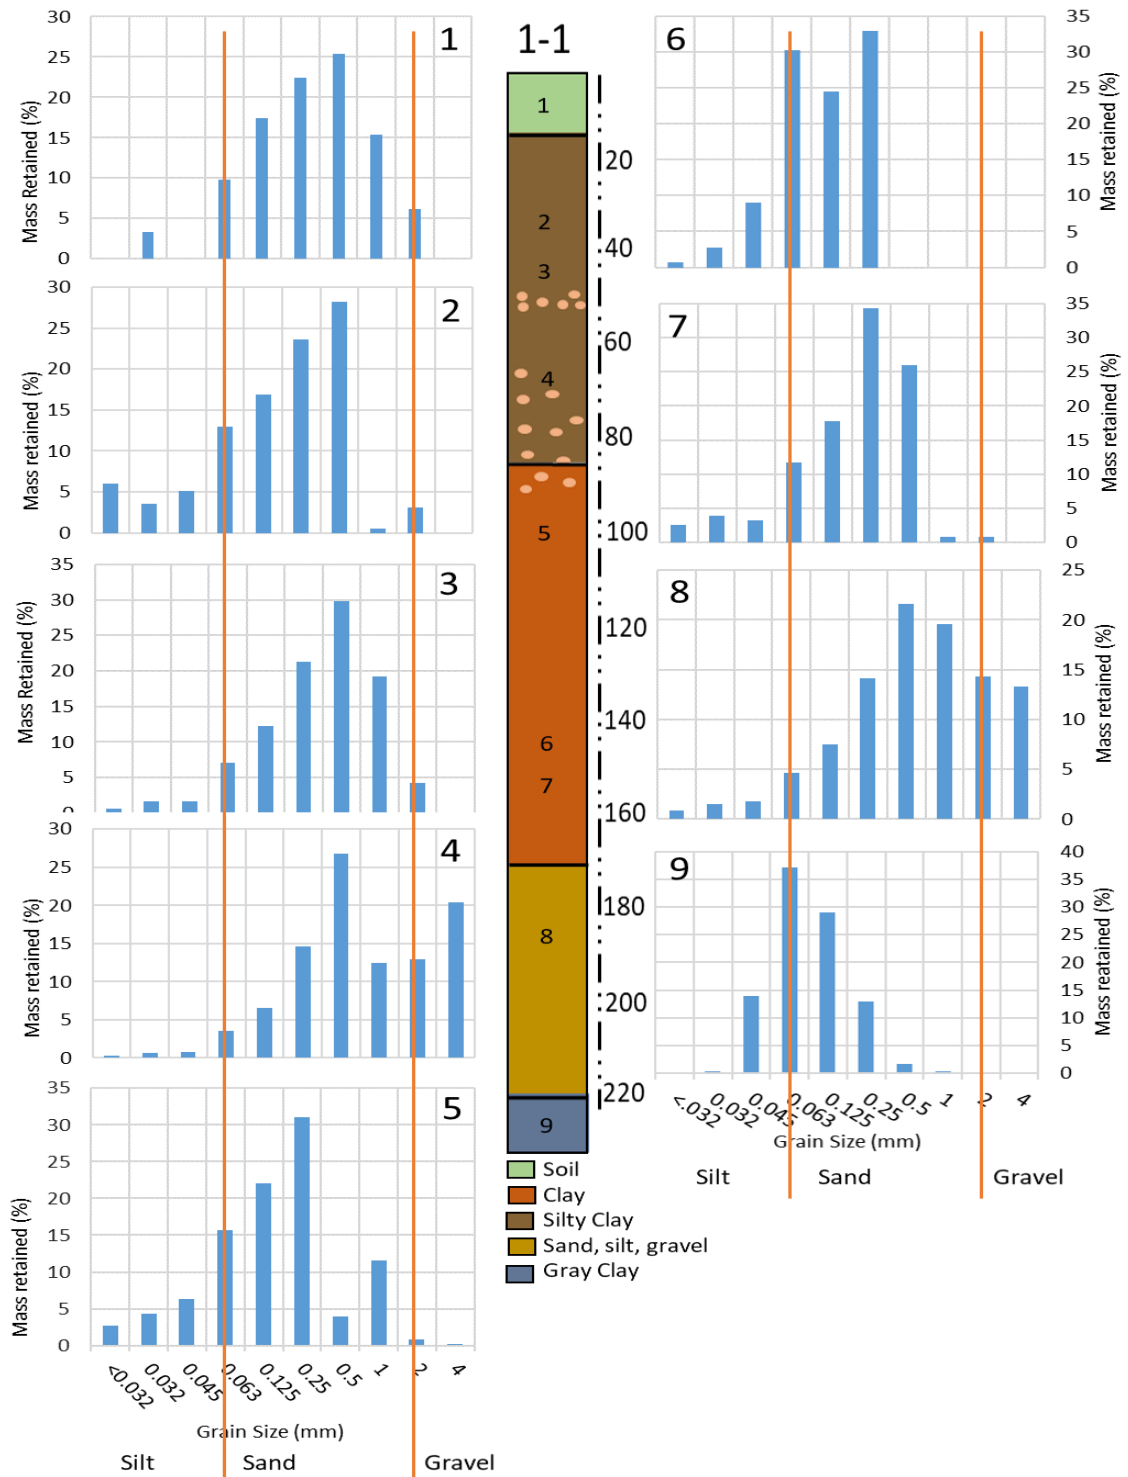
Figure 17. Sieve results from site 1-1 associated with the depth from which they were collected. Numbers in the upper left corner of the graphs correlate to the sample numbers on the stratigraphic column. Graphs show the grain size analysis as mass percent for each sieve range. Sieve sizes are in millimeters. Clay is <0.004 mm and contained within the <0.032 bin.

The sieve results show the majority of the mass throughout the column to be 0.25 mm and smaller (Figure 17). Significant variation exists in the overall grain-size distribution of the column and within each zone. The silt zone shifts from a high percentage sediment <0.25 mm in the upper portion to a high percentage of sediment >0.25 mm in the lower portion. Results from units 5, 6, and 7 in the silt/clay zone show the zone containing a majority of sediment <0.25 mm.

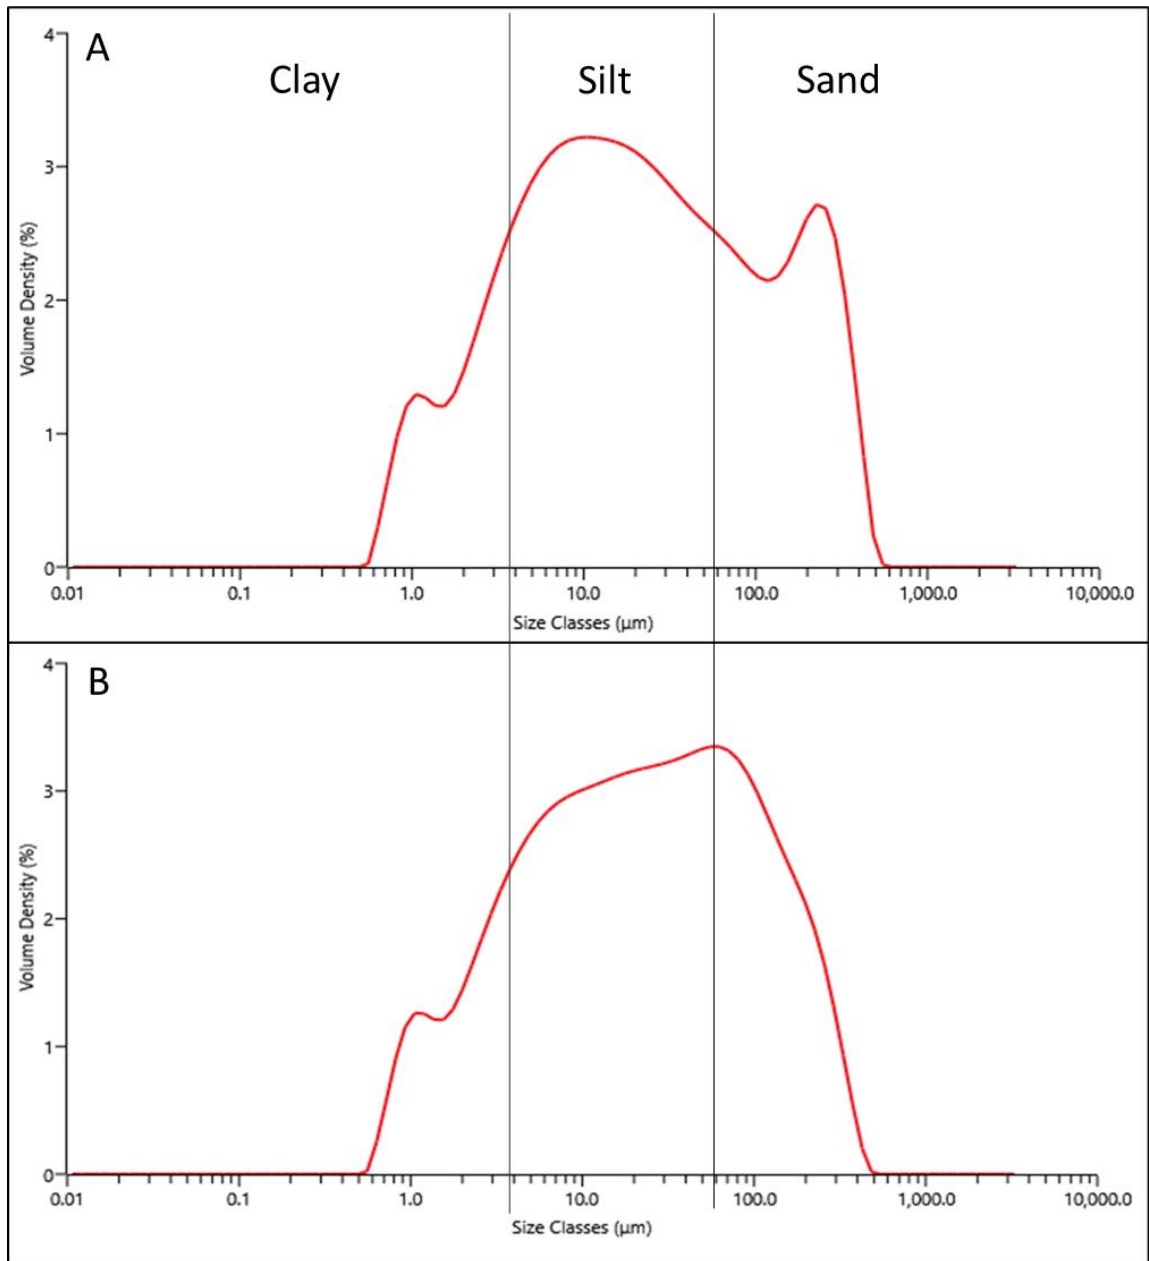
Figure 18. Mastersizer results. Graphed results shown are from the zones within stratigraphy site 1-1 that contain the most clay and least amount of sand and larger sediments. A) represents unit 5, B) represents unit 6, C) represents unit 7, and D) represents unit 9. Mastersizer graphs of the remaining units are in Appendix C.

Samples 2-10 were also analyzed using the Mastersizer 3000 LV for the sediment-size distribution of the fine sediment within each unit sample. Mastersizer results show the size distribution of all unit samples after the removal of all grains larger than 0.5 mm. Results from the units from the silt/clay zone and the gray clay zone show the volume density percent of the units to be (Figure 18). The sediments within units 5, 6, 7, and 9 contain a large volume of grain-sizes of silt and smaller. Masses of the samples and graphs from each unit are in Appendix C. These results confirm the results of the sieve data and show the volume of fine sediment within the zones.

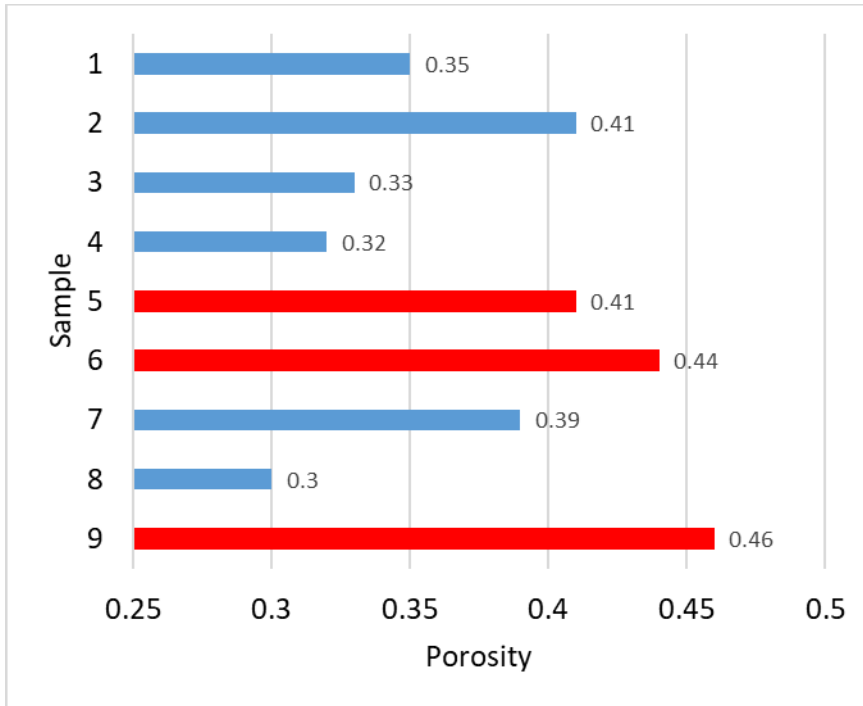
Figure 19. Porosity for site 1-1. Values in blue were calculated using HydrogeosieveXL. Values in red were calculated using values from Schwartz and Zang (2003).

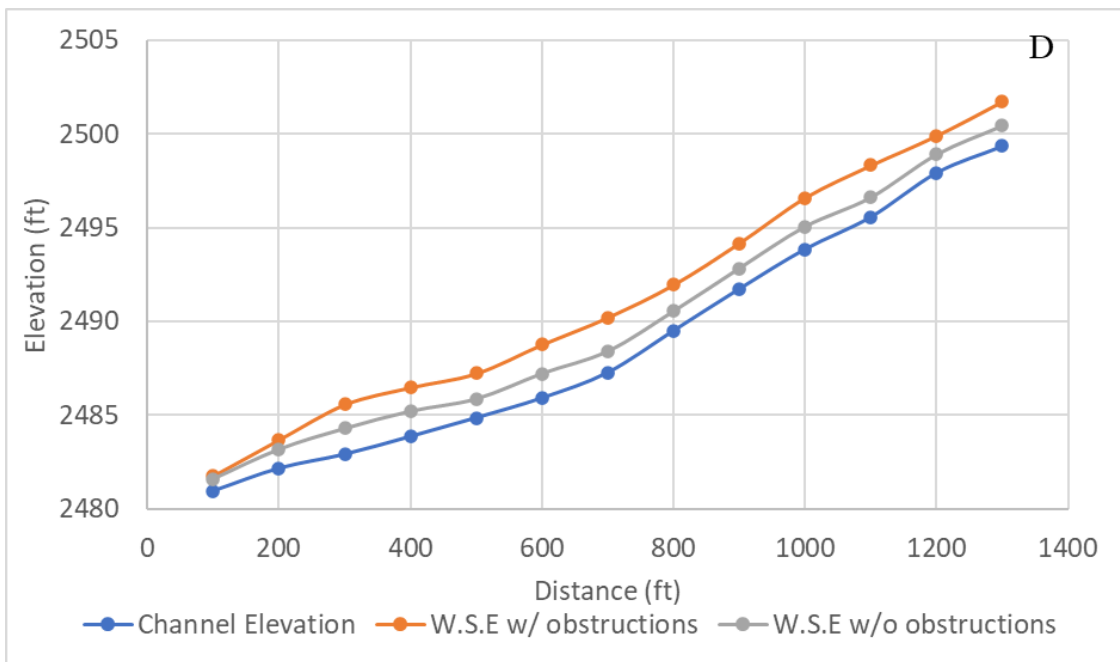
Figure 20. HEC-RAS model results. Water surface elevation comparison of the four modeled discharges. A) 6.0 ft³/s, B) 13.4 ft³/s, C) 15.9 ft³/s, D) 36.4 ft³/s. The gray line represents the WSE without obstructions. The orange line represents the WSE with obstructions. The blue line represents the minimum channel elevation. Detailed outputs from the model are in Appendix D.

The model results show the addition of LW in the stream channel causes an increase to the WSE (Figure 20). Differences in WSE between the two modeled scenarios increase with increased discharge (Figure 20). Mapped results from the model show floodplain inundation increase with increased discharge (Figure 21). The areas of inundation are areas the LiDAR determines as the same elevation as the stream, which causes the model to place water in the area. The increase is not necessarily due to overbank flow. Cross-sectional views show that at the highest flow the water is unable to overtop the banks (Figure 22). Detailed outputs from the model are in Appendix D.

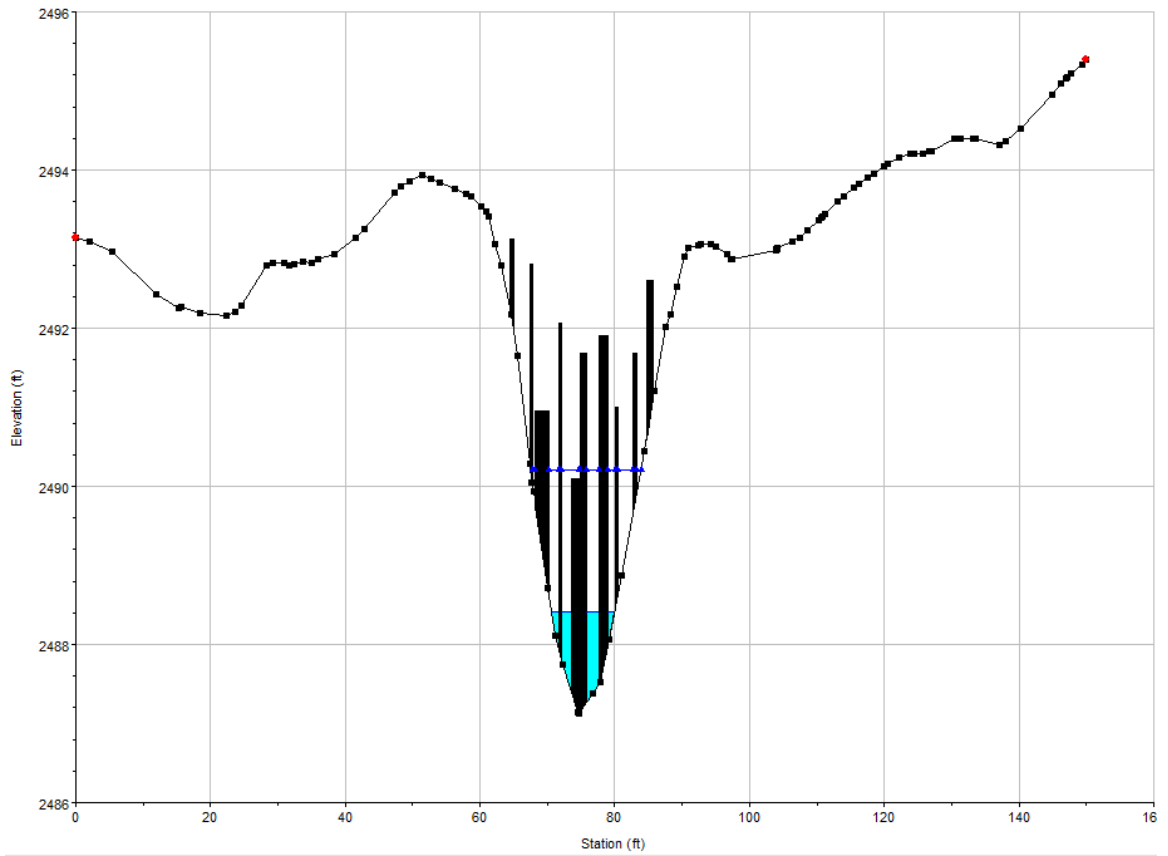
Figure 22. Example cross-section with in-stream obstructions of the difference in water surface elevation (WSE) with and without obstructions in the channel of the 36.4 ft³/s model. This is the cross-section located at 700 feet up the reach. The blue line with triangles represents the WSE with in-stream obstructions. The light blue filled area represents the WSE without in-stream obstructions.
