Assessing the Effects of Instream Large Wood on Floodplain Aquifer Recharge and Storage at Indian Creek, Kittitas County, Washington, USA

A Thesis
Presented to
The Graduate Faculty
Central Washington University

In Partial Fulfillment
of the Requirements for the Degree
Master of Science
Geological Sciences

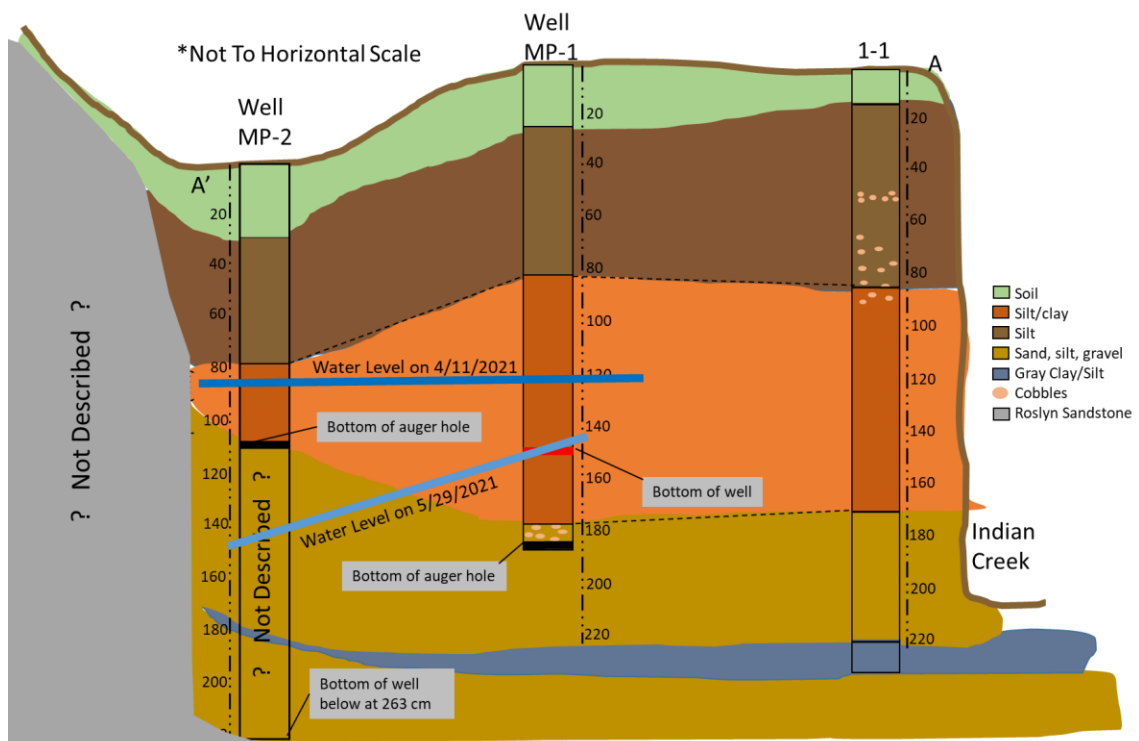
Figure 23. Cross-sectional interpretation of the stratigraphy of the floodplain at the downstream wells from the hillside to the streambank. The Stratigraphy of site 1-1 was placed as the stream bank stratigraphy due to the similarities in stream bank stratigraphy. Water lines show the depth of the water in MP-1 and 2 on 4/11/2021 and 5/29/2021. The dates of the groundwater levels shown here are the same dates in groundwater gradient figure (Figure 24)

Recent floodplain restoration work in the fall of 2020 near the upstream well cluster filled an approximate 2-meter incised drainage channel with large piles of small woody debris (SWD) and dirt. The SWD piles are spaced so that pools of water develop between them. At the end of winter, the spaces between the SWD contained enough water to fill the depth of the channel. Water remained in most of the pools throughout the summer of 2021, creating stagnant ponds. The gray clay/silt zone was found just beneath the bottom of the channel prior to the SWD installation. A ponded portion of the channel is located approximately 10 meters northwest of MP-4 (Figure 5). The presence of the pooled water so close to the well did not have a noticeable effect on maintaining or increasing the GW level in MP-4 or MP-5 (Figure 12). The lack of change to the GW levels in the wells might be related to the GW flow direction results noted by Boylan (2019) showing the GW at the upstream wells flows northwest, away from Indian Creek (Figures 23 & 24).

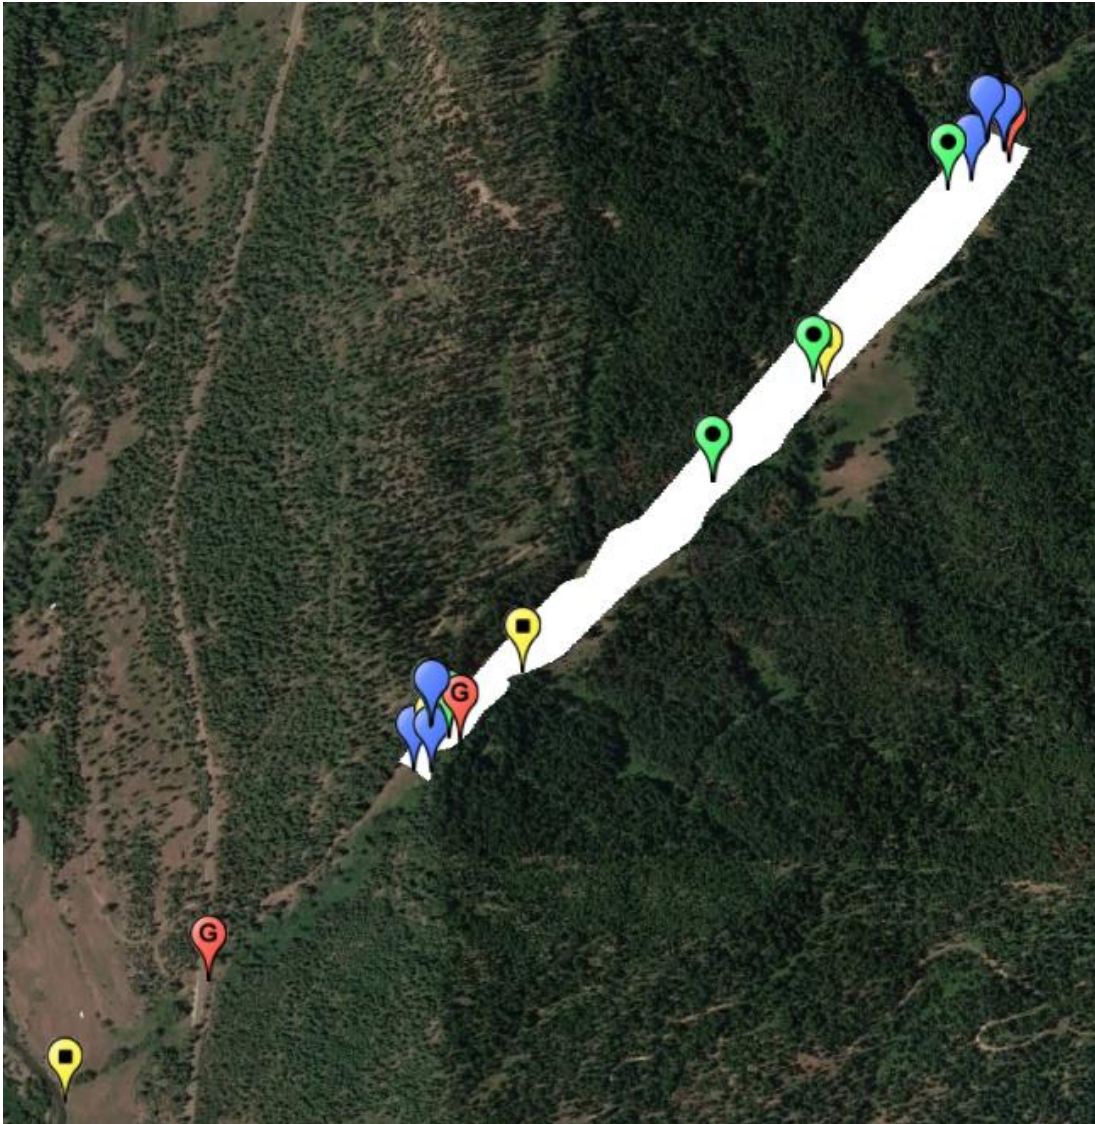
Figure 25. Area polygon used for potential storage capacity. The polygon extends from the furthest upstream well to the furthest downstream well; from the approximate location of the stream channel to the northern hillside.
